Gold Coast Seaway Breakwater Stability Assessment

PIANC APAC Conference – August 2024

Paul Prenzler and Adam Norris

28 August 2024

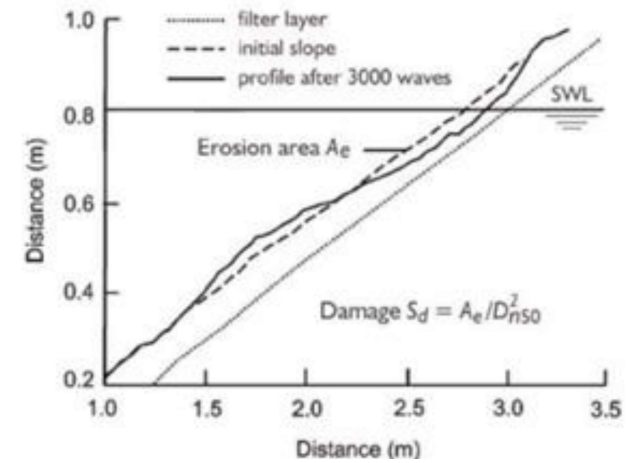
Damaged profile of a rock armour slope, due to hydraulic instability (S-shape)

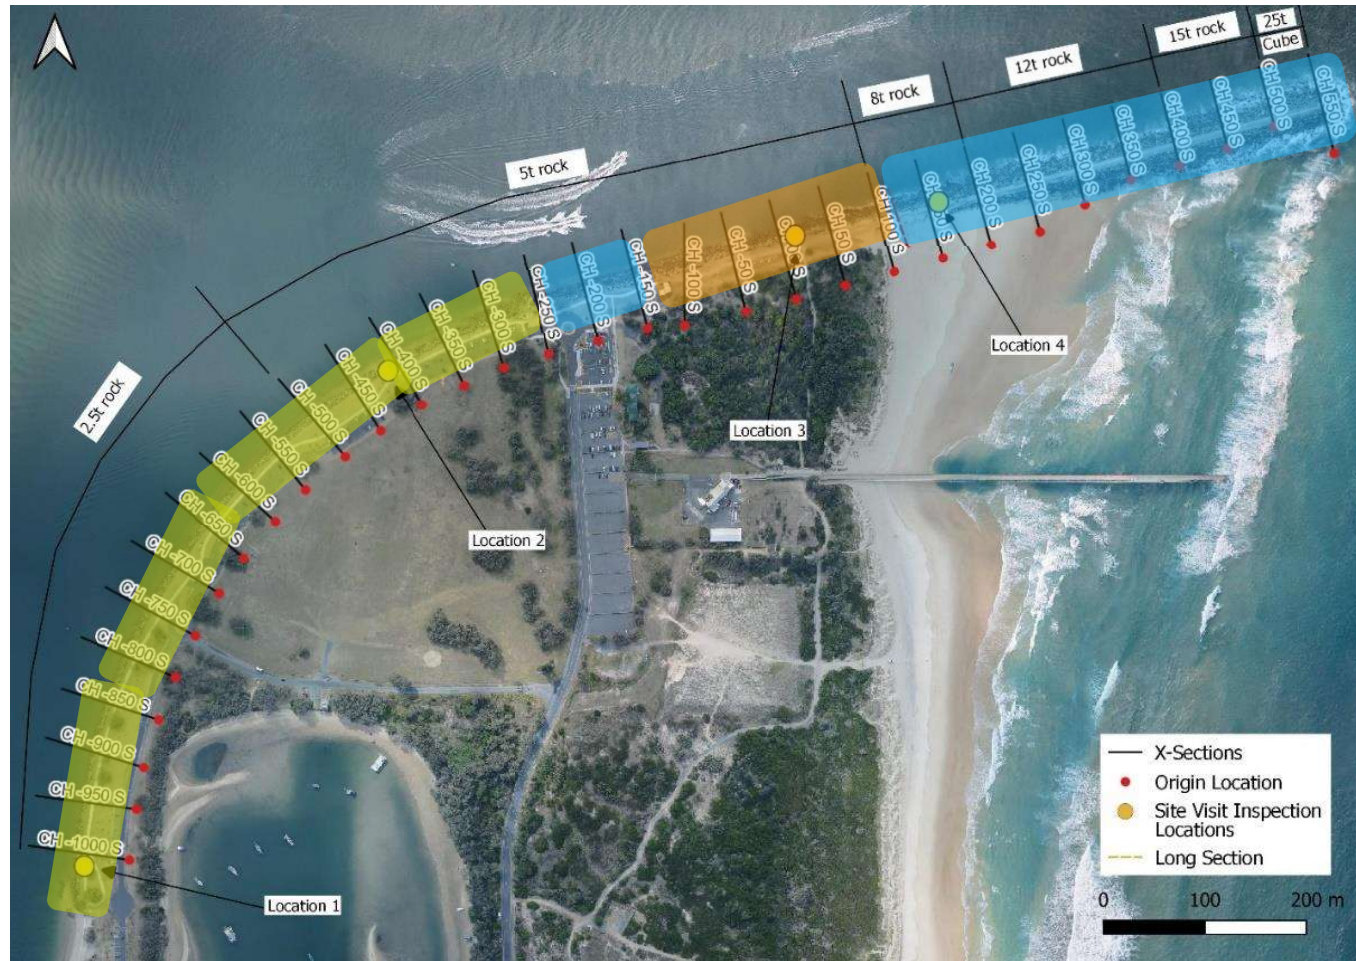
Seaway Southern Training Wall:

- 1550m in Length
- Armour varies from 25t to 2.5t

Chainage	Condition Rating	Est. Remaining Life (% of Original Design Life)
-1000 to -250	2	55-99
-250 to -150	3	41-55
-150 to 100	5	15-24
100 to 550	3	41-55

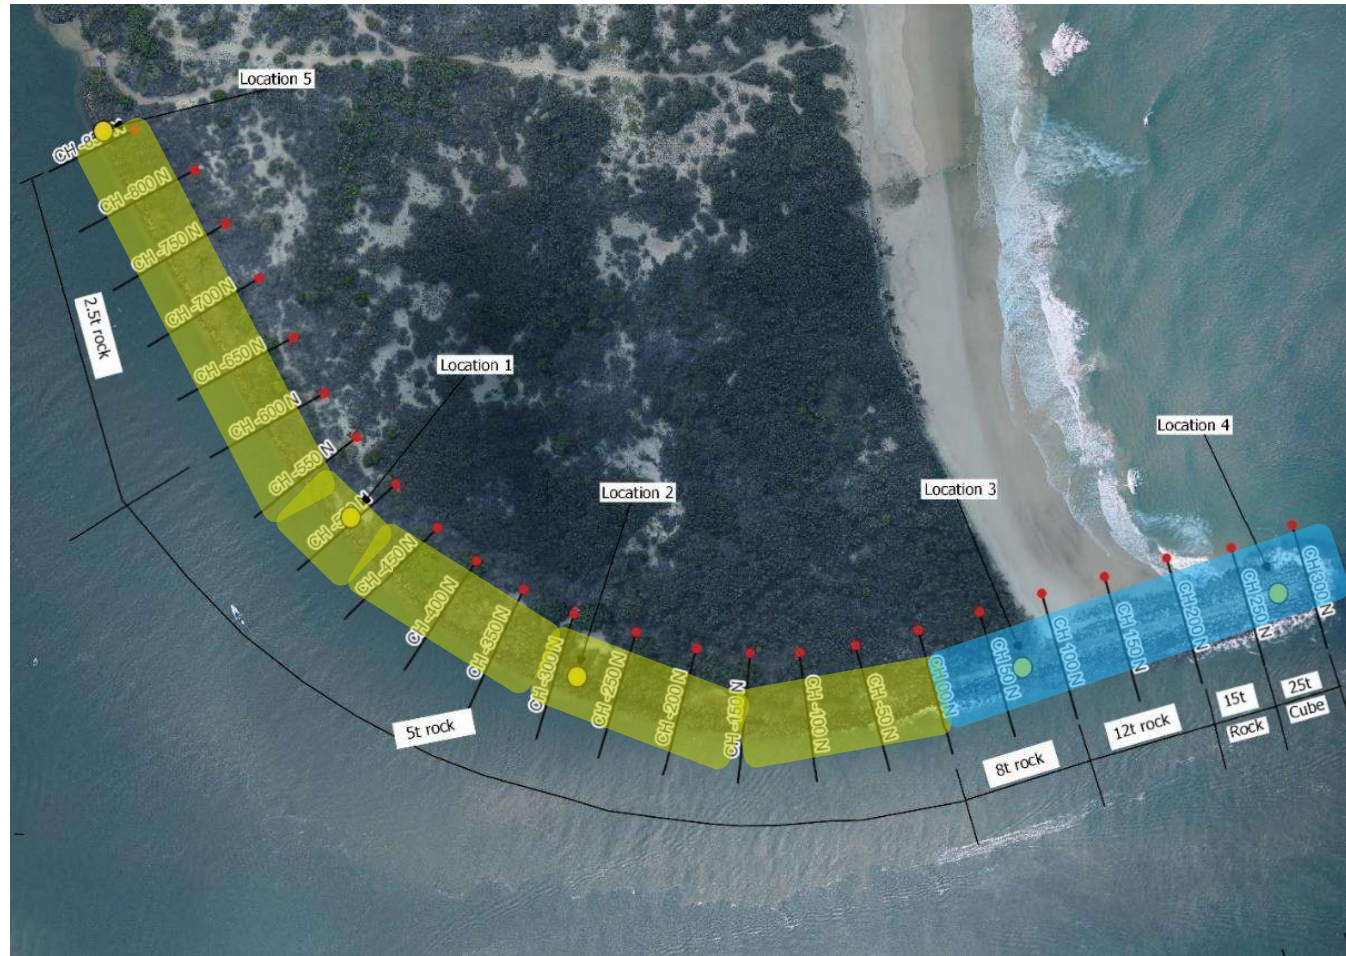
Seaway Northern Training Wall:

- 1150m in Length
- Armour varies from 25t to 2.5t

Chainage	Condition Rating	Est. Remaining Life (% of Original Design Life)
-850 to 0	2	55-99
0 to 300	3	41-55

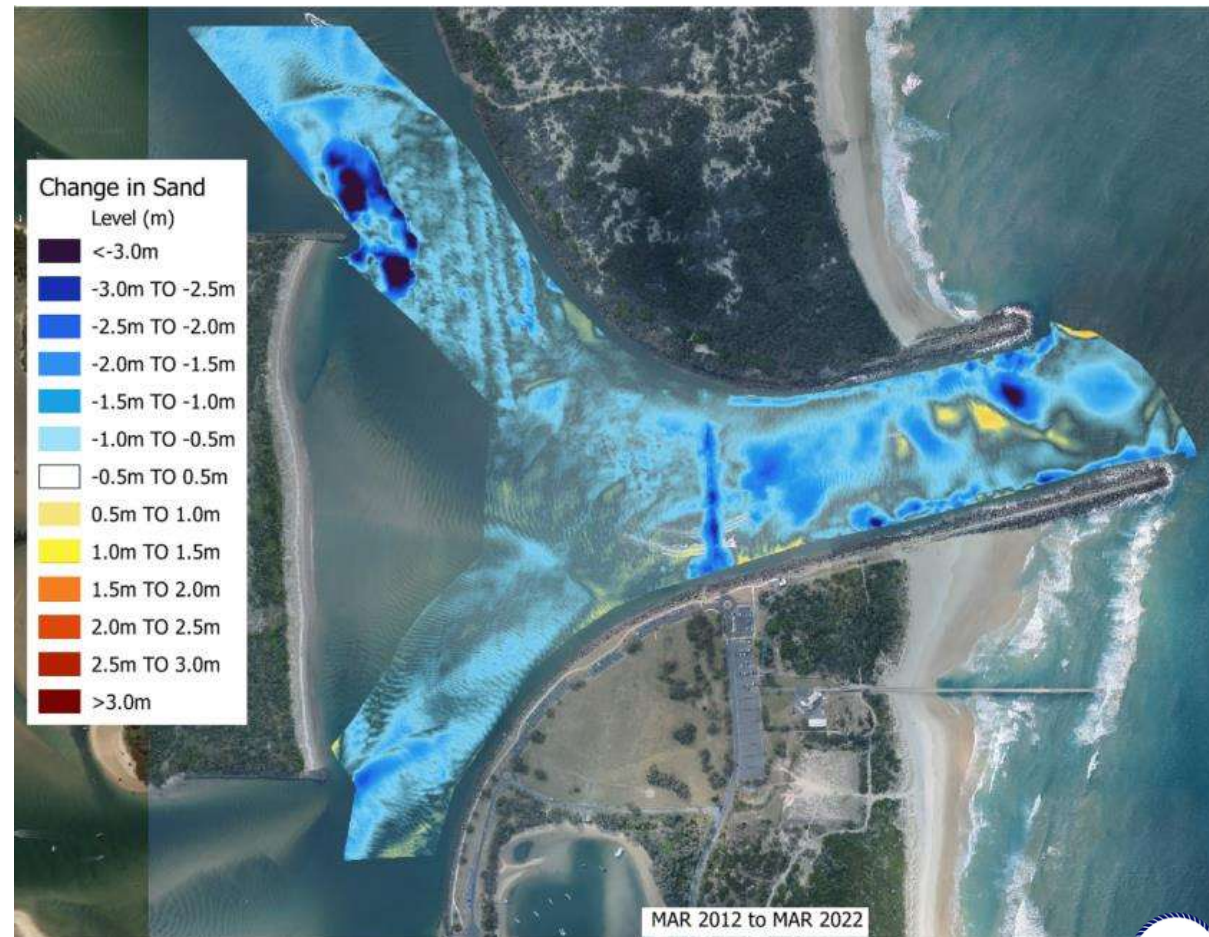
Analysis of survey (2012 – 2022):

- Scour at head of WBI northern breakwater has deepened and expanded
- Scour within the Seaway been relatively stable
- Slight changes to the scour at the head of the northern training wall

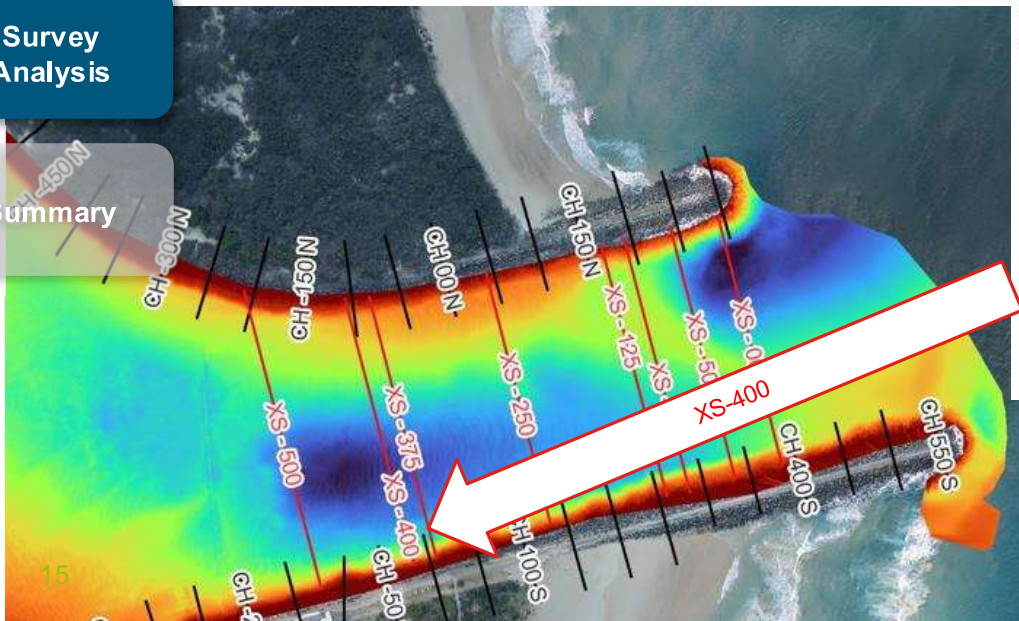
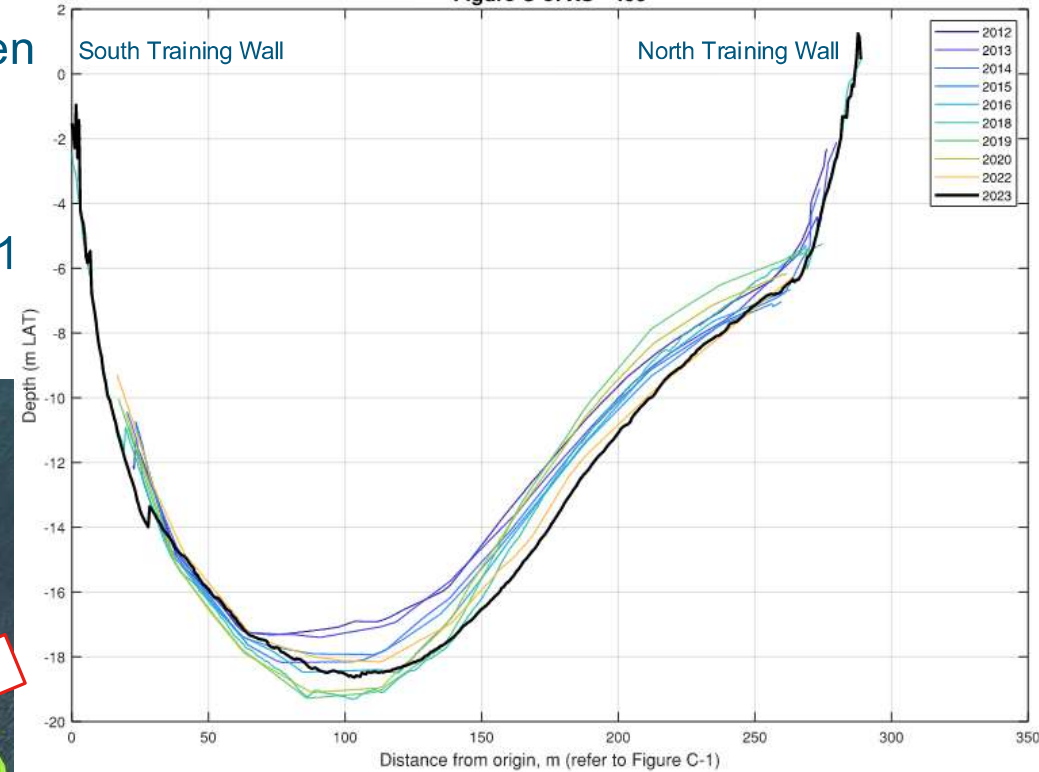
Figure C-8: XS - 400

Southern Training Wall

- Scour is continuing to slowly deepen and expand
- Currently -18m CD (1.5m/yr over 11 years)

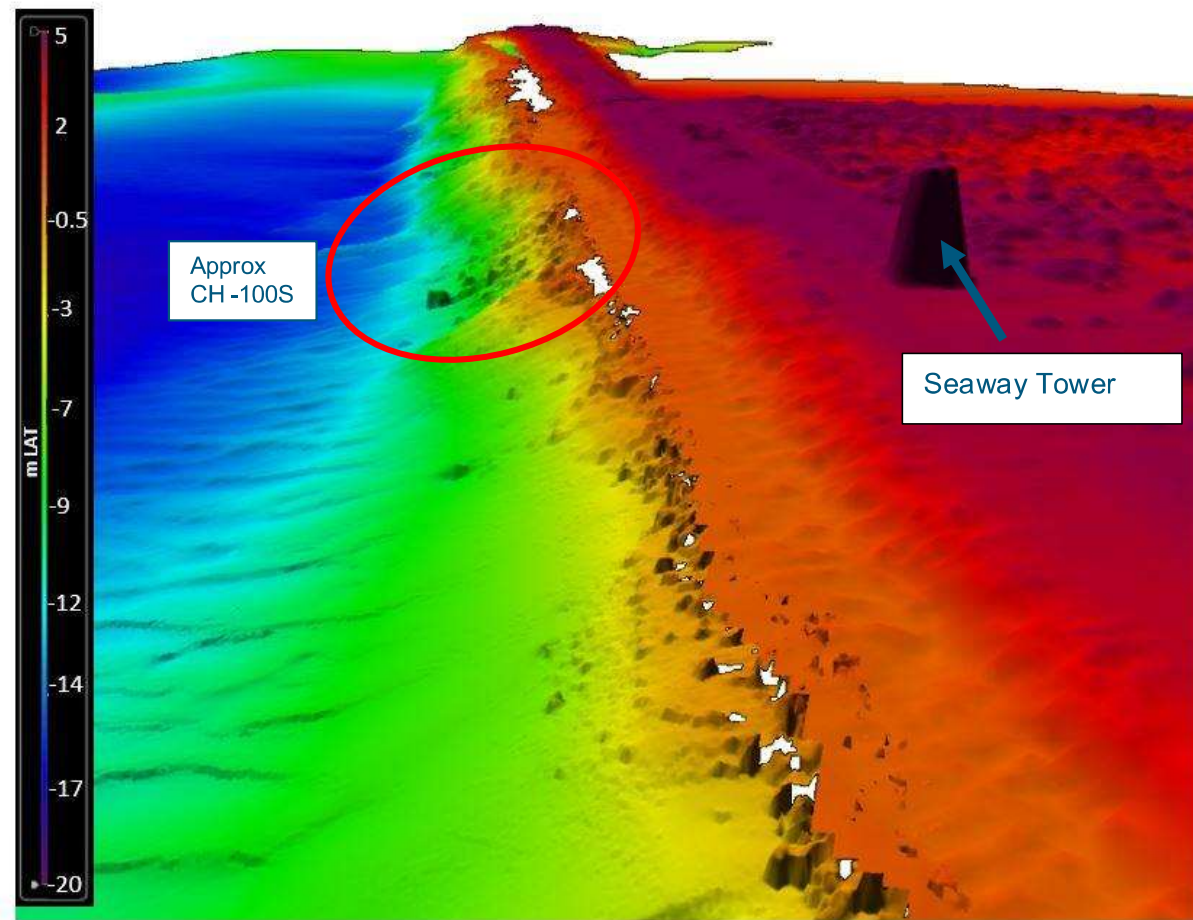
Southern Training Wall

- Deterioration between CH100S and CH-150S coincides with reduction in the design armour mass
- The toe berm is linear and relatively level along the length of the structure
- Scour at the toe of the training wall is expected to lead to reshaping /slumping of the toe berm

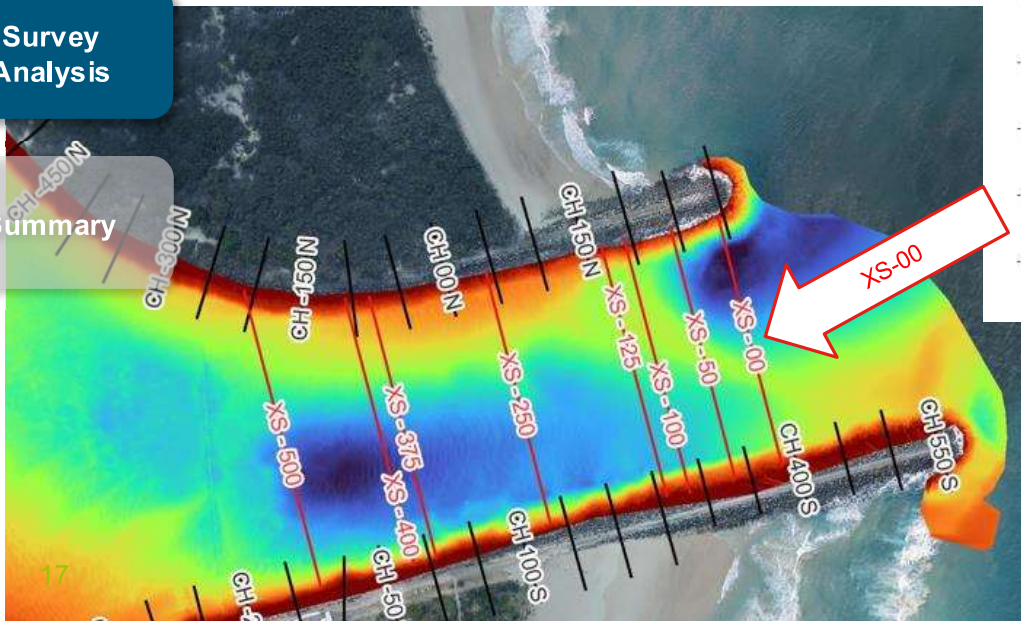
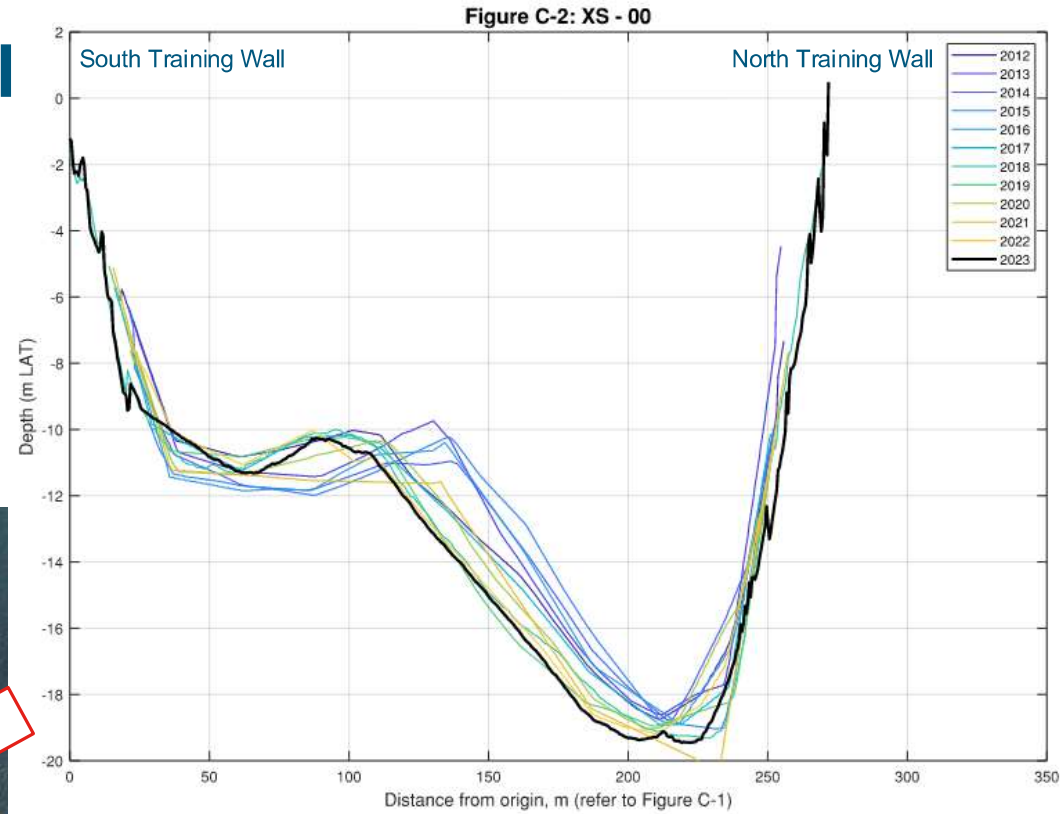
Northern Training Wall

- Scour is slowly expanding
- Currently -19m AHD

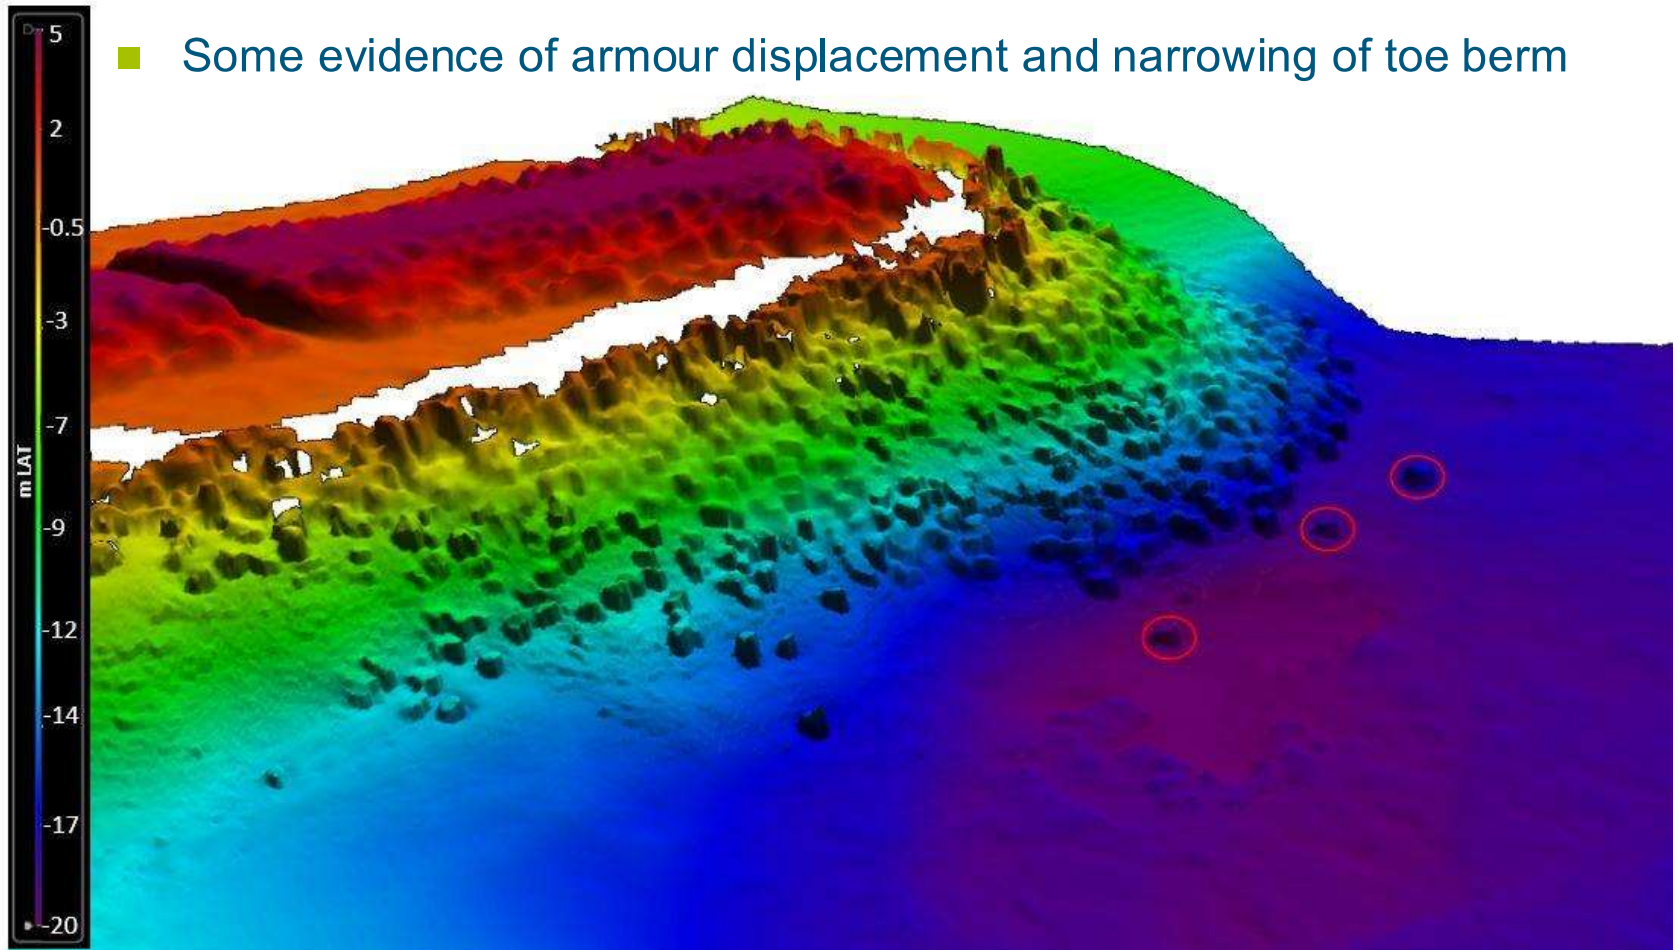
Northern Training Wall

- Some evidence of armour displacement and narrowing of toe berm
