Case studies involving management of thruster currents at the Overseas Passenger Terminal, Sydney Cove

- Two field data collection projects:
 1. Navigation risks for ferries operating in Sydney Cove
 2. Asset protection of OPT wharf and berth pocket

Sydney Cove and the Overseas Passenger Terminal (OPT)

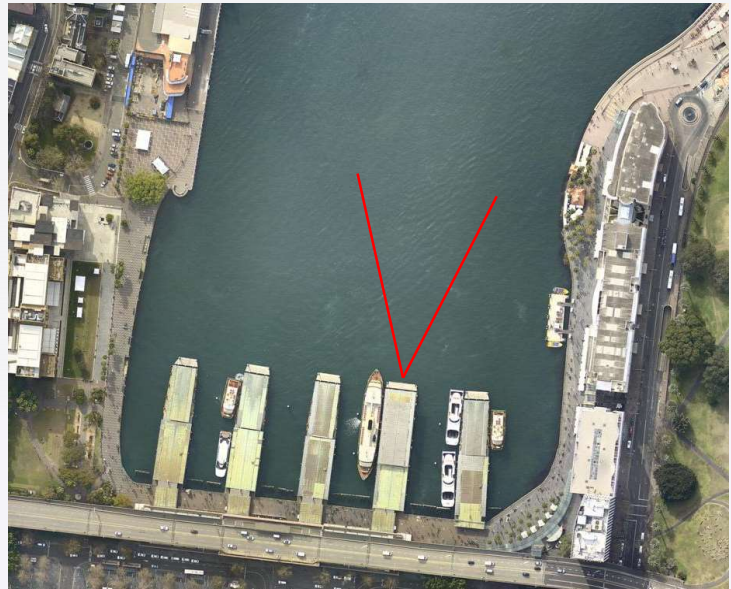
Horizontal ADCP

Mounted on Wharf 3

Possible range up to 150 metres

Assumes homogenous flow

Depth limitations

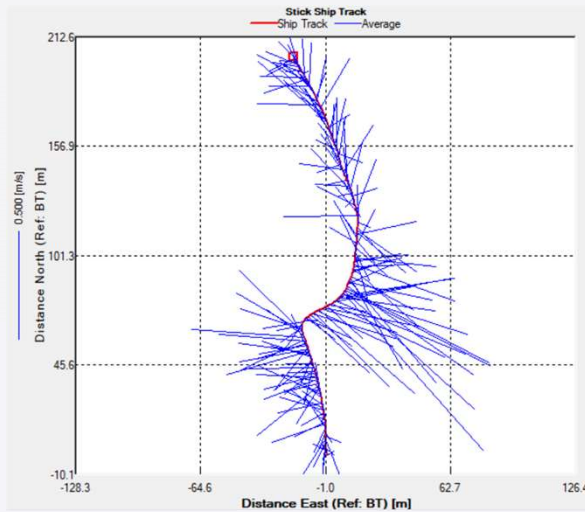
Vessel transect measurements

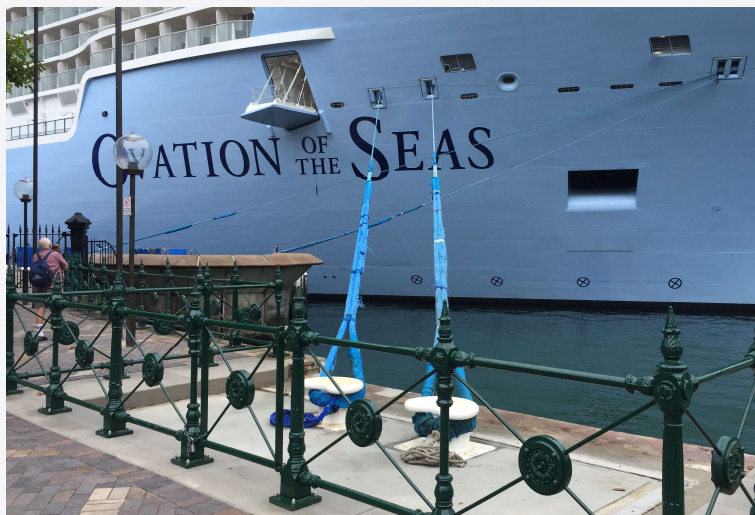
A number of observations from both landside and from hydro survey indicated bed scour and wall impacts were occurring.

Port Authority hydrographic survey increased frequency of OPT surveys to investigate

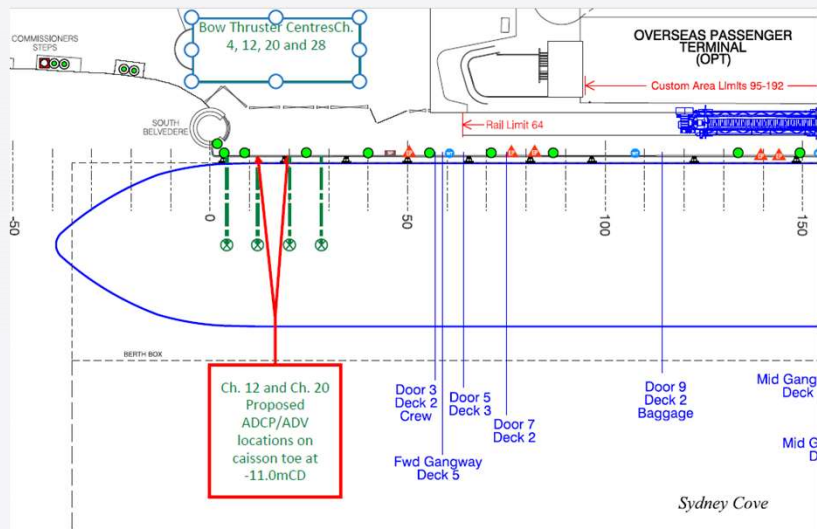
Installation of Vector ADV instruments

- 3 instruments to be installed
- Placed at base of wall aligned with thruster positions

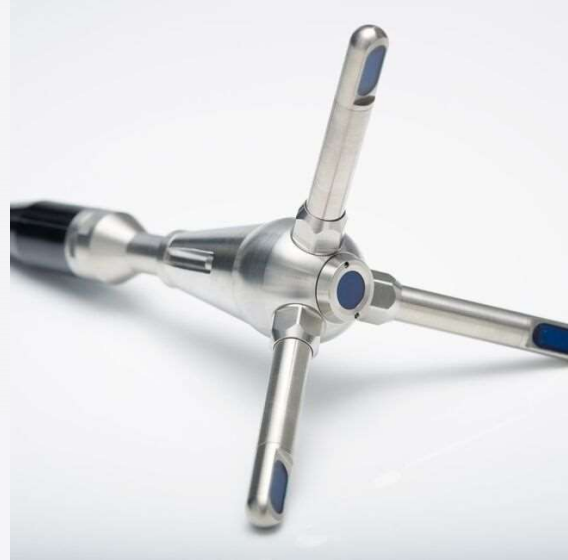
Nortek Vector ADV

Single point current
measurements from small
volume of water

Allows measurements of
turbulent currents

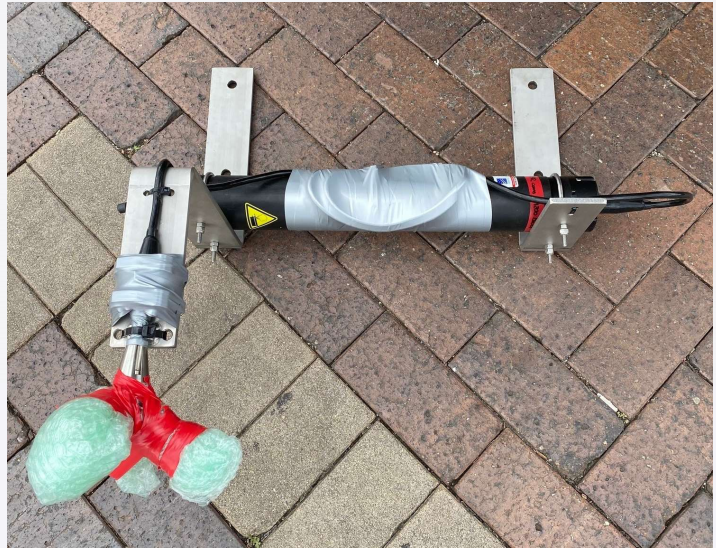
Installation

Diver installation

Bolted to caisson

January 2020 – April 2020

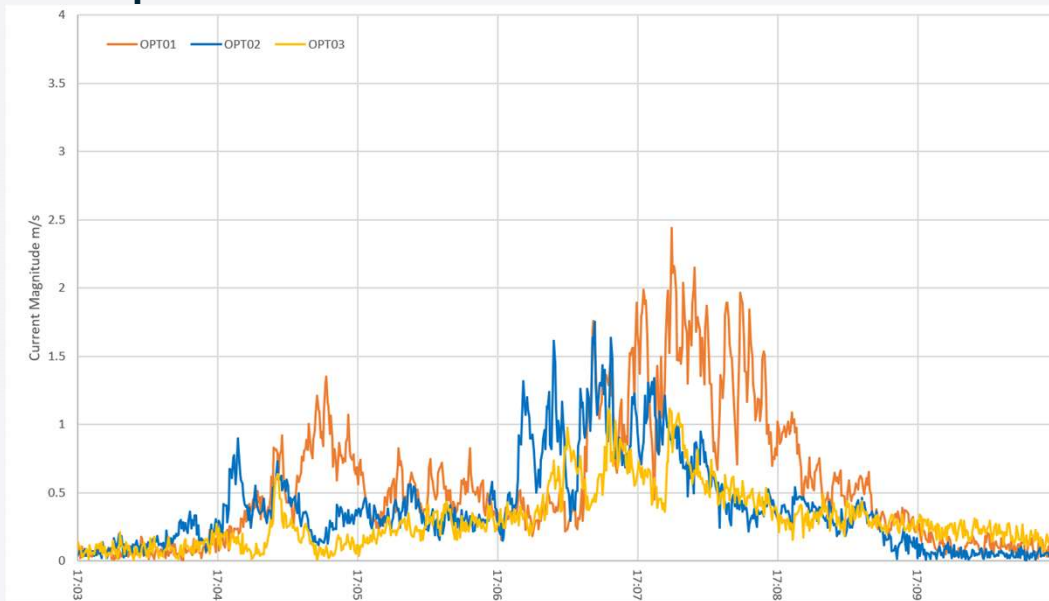
Typical departure currents
