Coastal Hazard Management at Fremantle Ports

Connecting Western Australia to the world

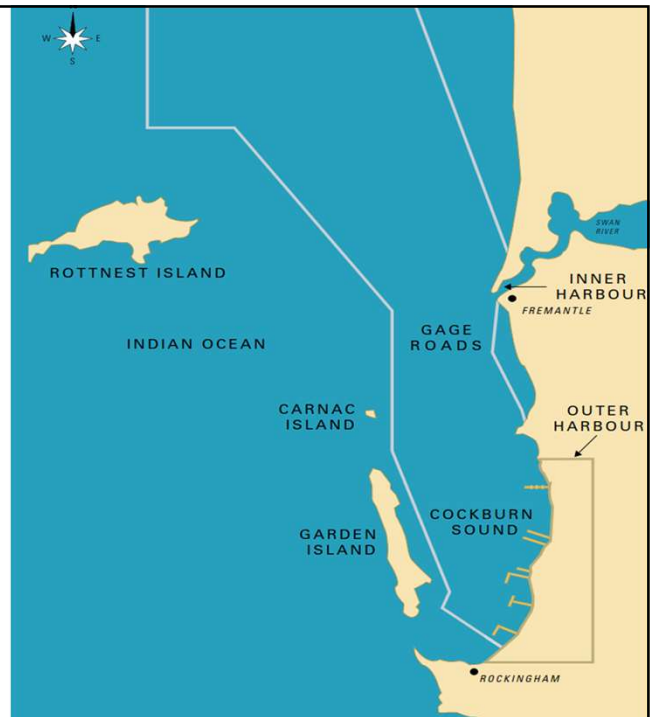
Fremantle Ports

- Inner Harbour in Fremantle
 - Container Trade
 - Bulk Cargo
 - Vehicles
- Outer Harbour in Cockburn Sound
 - Kwinana Bulk Terminal
 - Bulk Goods
 - Kwinana Bulk Jetty
 - Bulk Liquids

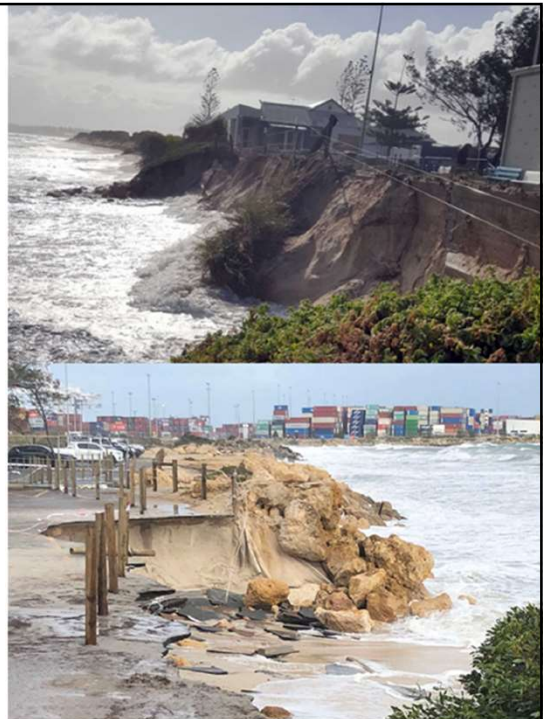
3

Port Beach Erosion

- Erosion caused by longshore sediment transport and severe storm events
- 7,500-10,000m³ of sand lost each year
- Images are from a severe storm event in 2019

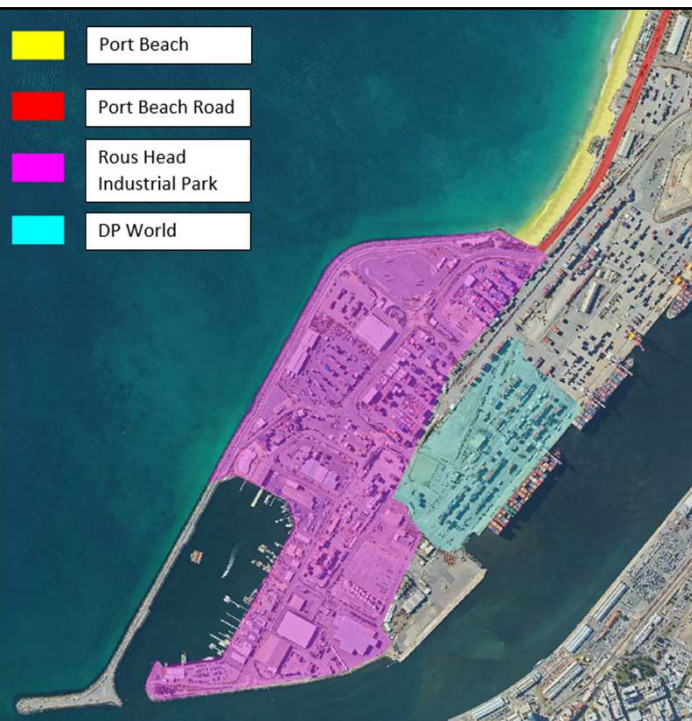
Port Beach Erosion

- Port Beach Rd is the only access road for the Rous Head extension
- 4 adaptation options were assessed
 - Retreat and Protect
 - Protect
 - Headland / Groynes
 - Sand Nourishment via (Truck or Dredge)

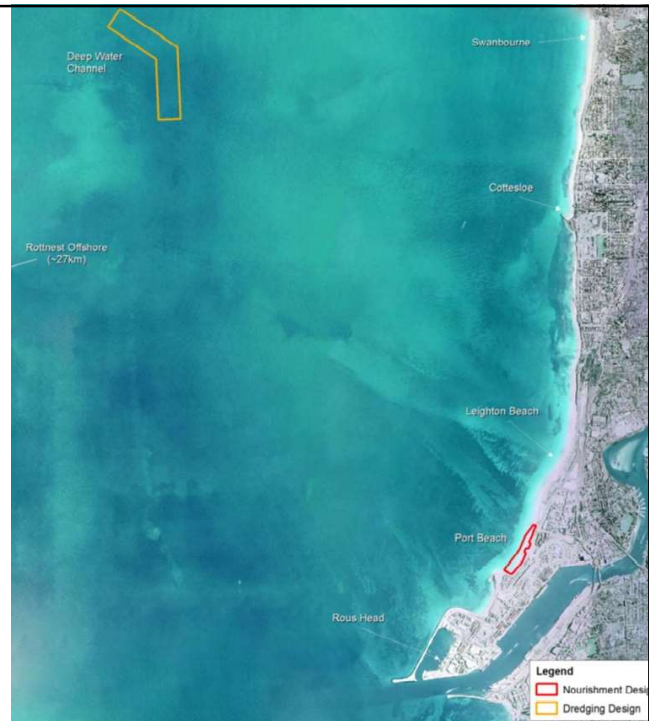
5

Sand Nourishment Design

- 150,000 m³ dredged from Deep Water Channel
- Dredged material designed to be rainbowed onto a 750m section of Port Beach
- Design life is estimated to last 7-8 years

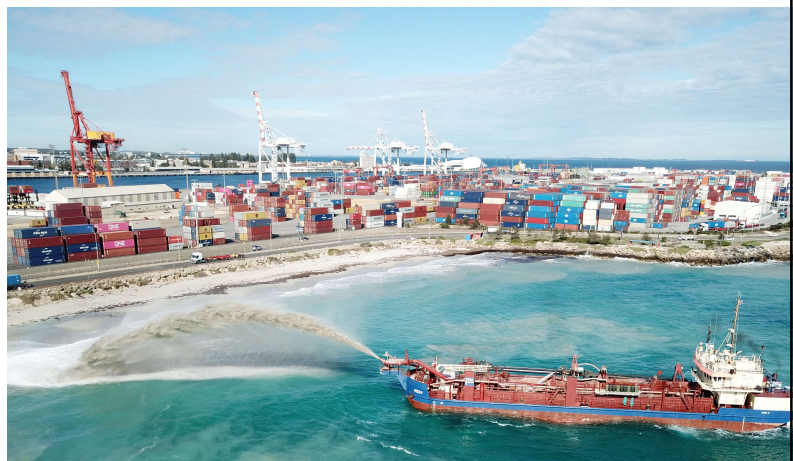
6

Sand Nourishment

- 500 T of small rocks removed
- 850 T of granite rock wall removed
- 47,000 m³ of sand placed on Port Beach to date

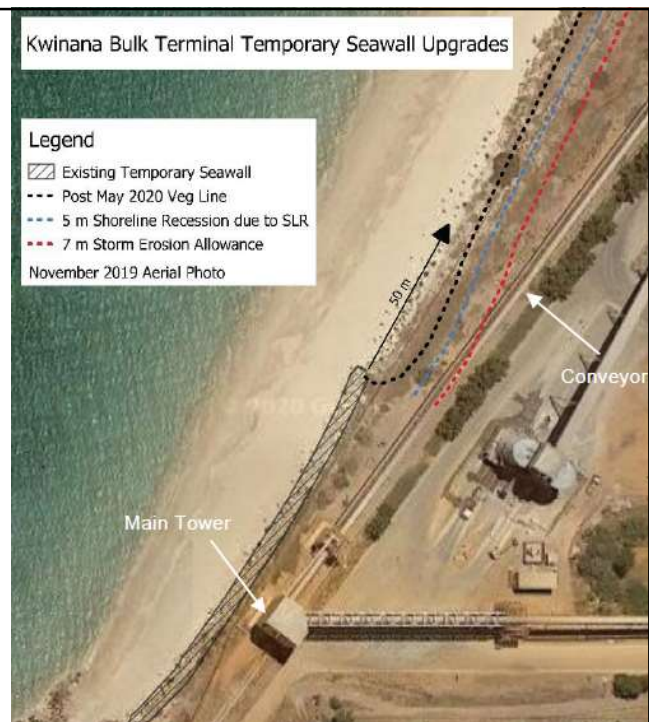
7

KBT Seawall

- 120m seawall constructed in 2013
- Proceeding storms in 2020, The new erosion allowance encroached on the main export conveyor

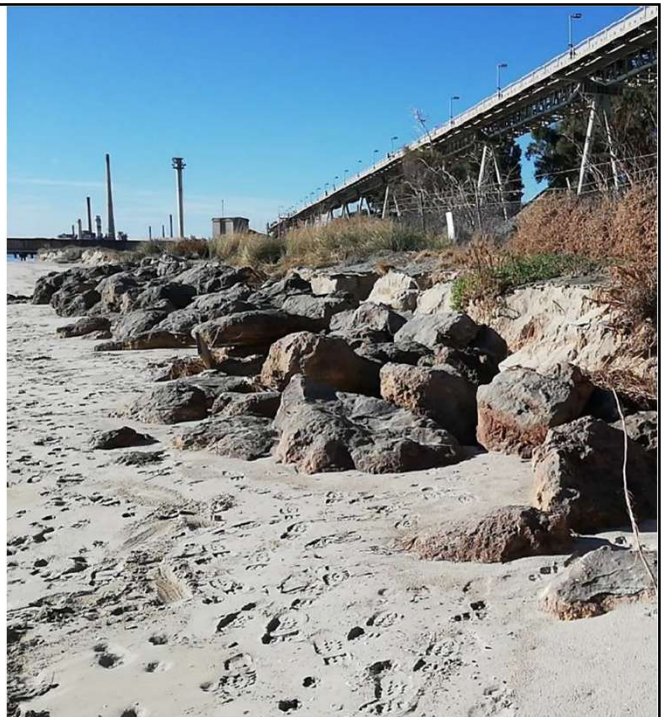
8

KBT Seawall Damage

- Failure occurred in May of 2020
 - Loss of crest elevation
 - Roll out of armour rock
 - Failure of sections of the structure

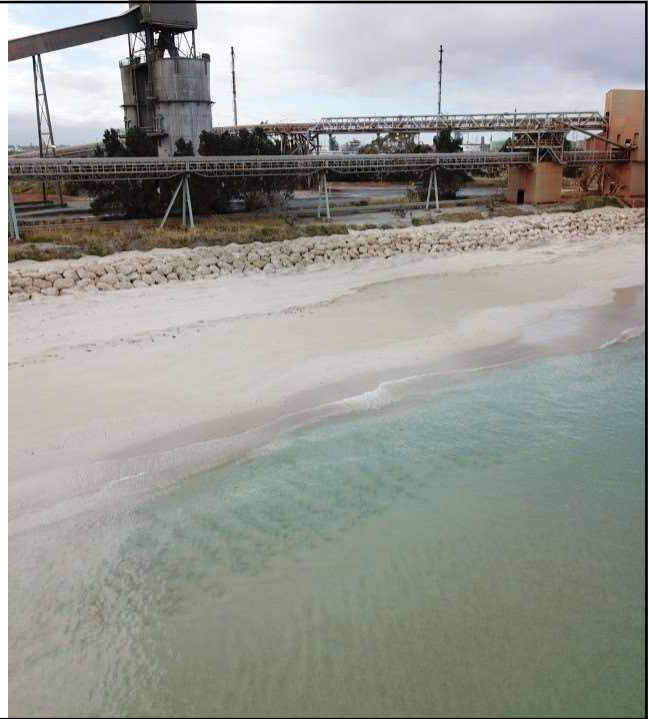
9

New KBT Seawall

- 20 year ARI wave height – 1.13m
- 20 year ARI water level – 1.48m AHD
- 10 year sea level rise – 5cm
