PIANC
APAC
2024

Innovations in Shiploader Technology for Wharf Environmental Management – QAL Case Study

Dr. Adam Mayers – Principal Mechanical Engineer
Aspec Engineering Pty Ltd

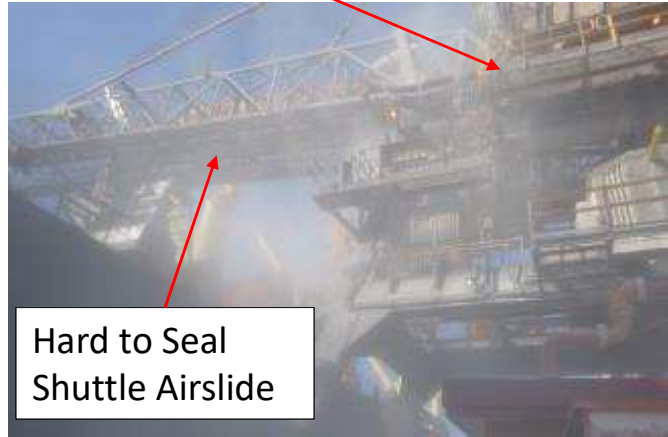
Chute opens up when luff up for hatch changes

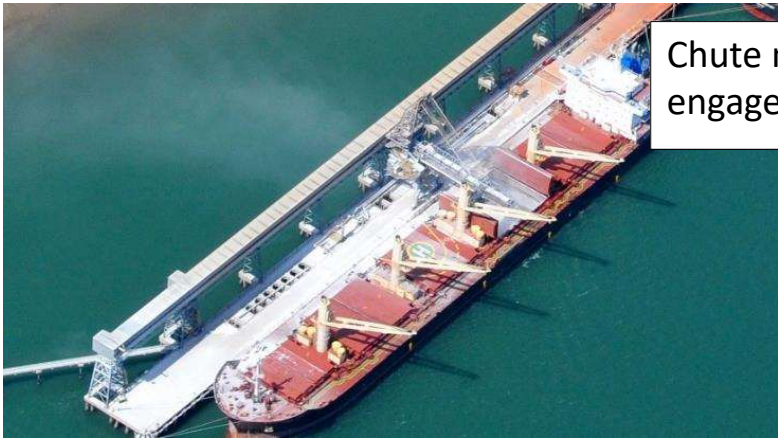
Chute not engaged with pile

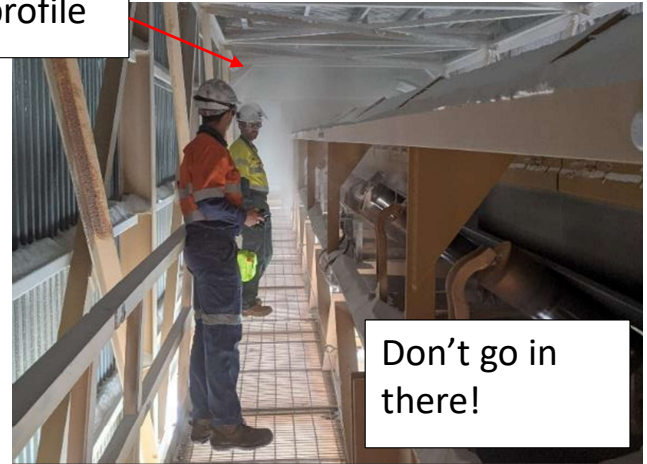
Tripper & belt profile
