**PIANC
APAC
2024**

ACCELERATED LOW WATER CORROSION

A Problem for Reinforced Concrete?

Andrew Czerwinski, Principal Engineer

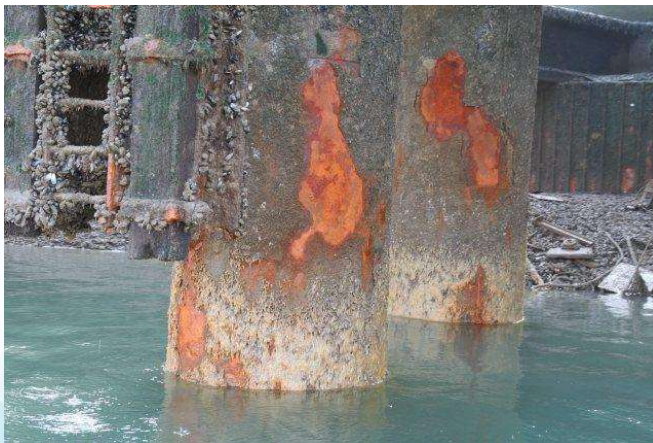
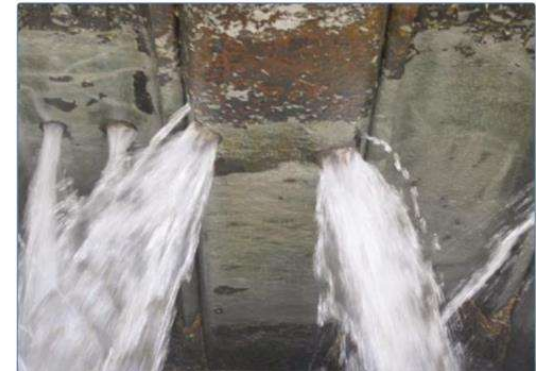
- rapid and aggressive (> 1 mm/year section loss)
- localised \rightarrow large pits & perforations
- microbially-influenced
- at or below low-water level
- often associated with bright orange corrosion tubercles

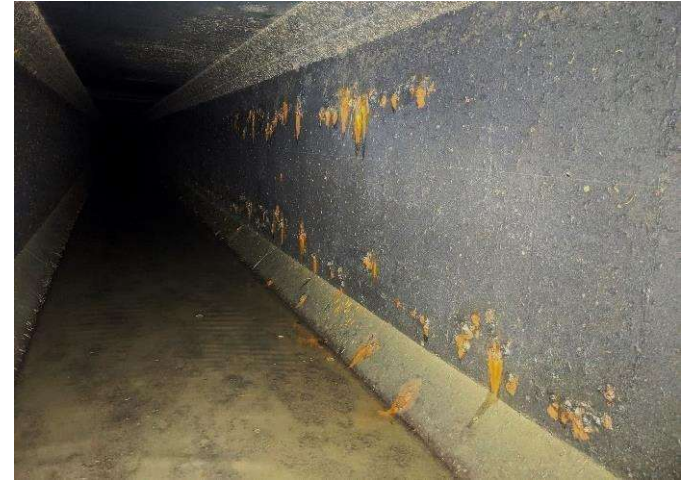
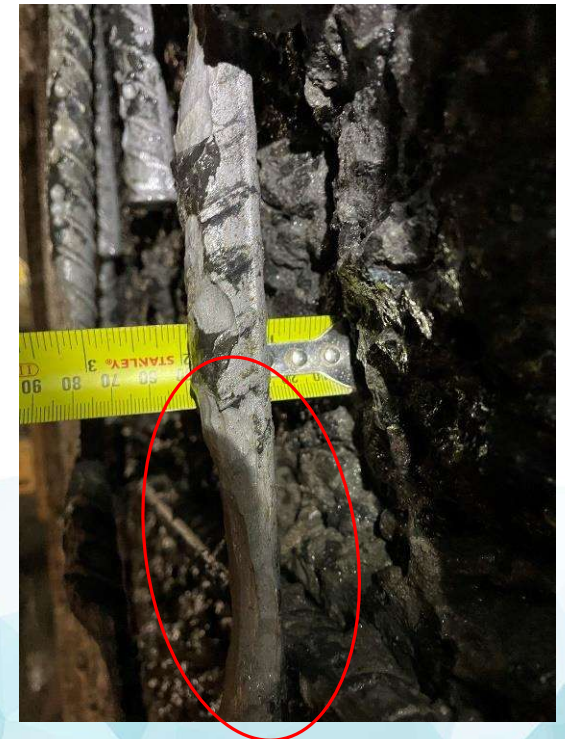
- Seawater-filled tunnels, made of reinforced concrete
- >40 years old. Drained annually for investigation and maintenance works
- Similar tubercules to ALWC on steel piles and SPW at nearby wharves
- Concentrated in areas of high steel density and lower concrete cover
- Substantial localised reinforcement section losses (sometimes through a 28 mm bar).
- Concrete not necessarily "drummy"

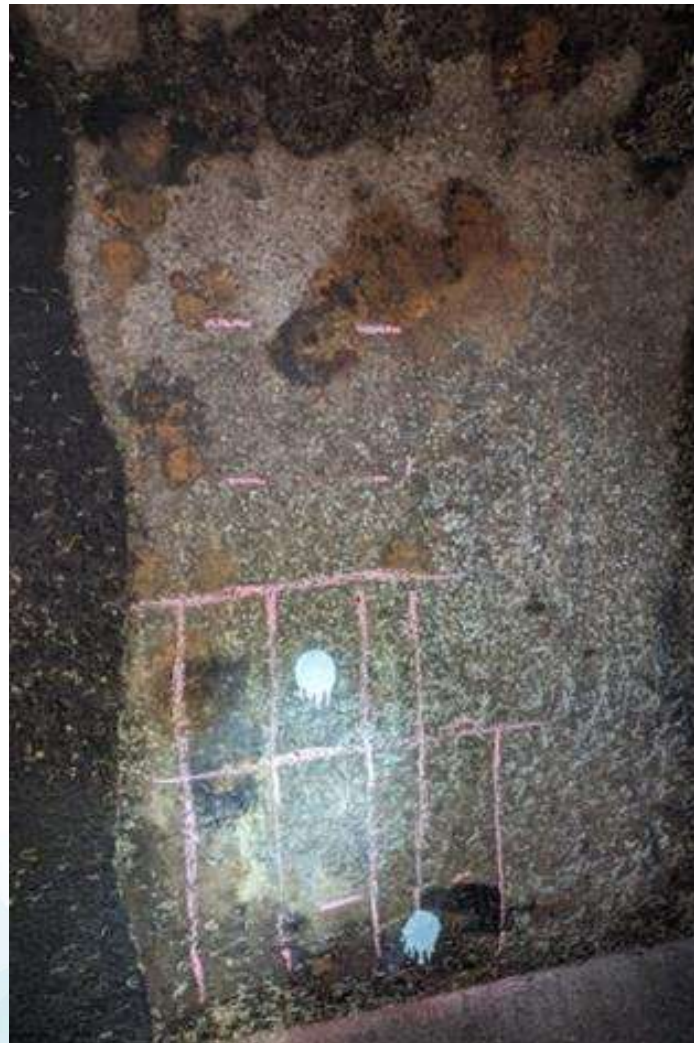
- Evaluated with ground-penetrating radar
- Tunnel wall shown:
(left) following pressure cleaning, and
(right) overlaid with concrete cover to reinforcement depth map (stated in mm)

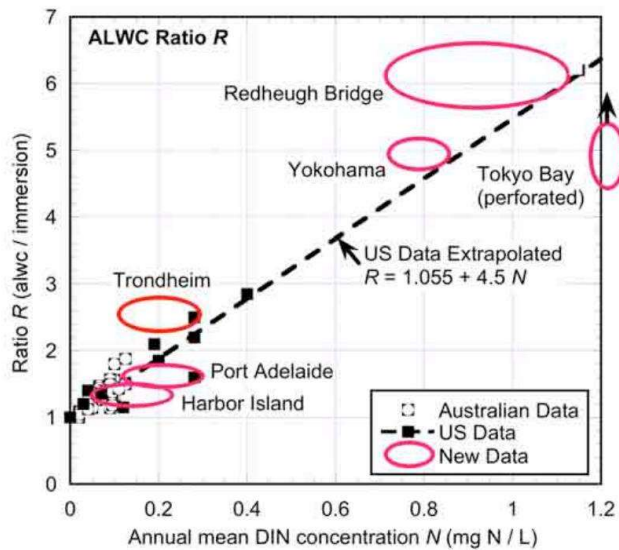
Correlation between dissolved inorganic nitrogen in water and contribution from ALWC

- (1) Reduce the nutrients in the water to decrease bacterial growth (stopping run-off and pollution is a good thing to do, but not generally something that an asset owner controls)

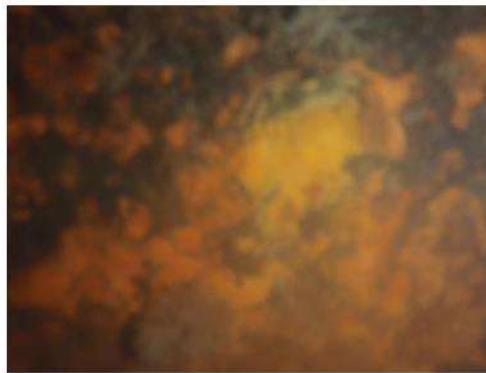
Figure 2

- Protection criteria in standards do not necessarily apply in the presence of ALWC. Need greater polarisation and target $-900 \text{ mV}_{\text{Ag/AgCl}}$ and not -800 mV (ISO 15589-1)
- Effectiveness of CP to mitigate ALWC may depend on bacteria present. SRB may require potentials as negative as -1032 mV vs Ag/AgCl (Little, Corrosion, 1993)
- New construction, Hunter River. Within 12 months, 50-70% of piles had orange corrosion blooms and 1 to 2mm pitting (Kreher, Corrosion and Prevention, 2015)

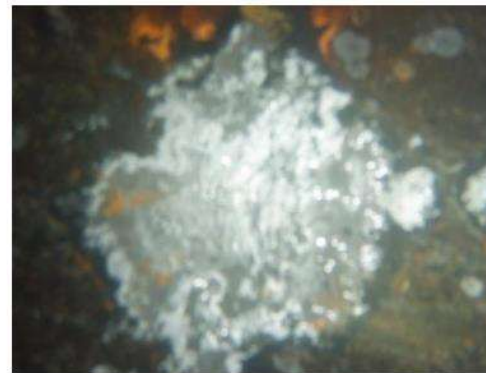
Figure 3

- Sacrificial CP required during construction prior to ICCP system installation .
- CP was effective “...indicating that polarisation levels greater -1000 mV vs Ag/AgCl are sufficient to achieve protection under the very aggressive ALWC conditions in the Hunter River mouth area”
