# Verification of a Probabilistic Coastal Erosion Hazard Line Assessment - Coromandel Peninsula (NZ)

*PIANC APAC Conference – August 2024*

# Thames Coromandel SMP Project

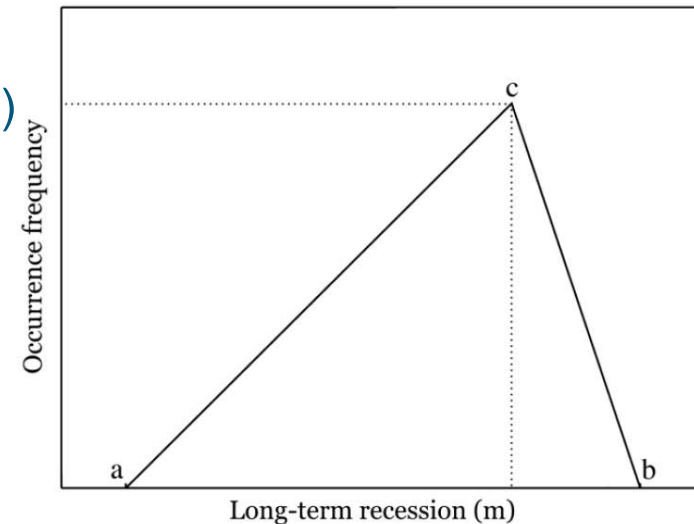
## Values and Distributions - LT

- Long-term shoreline recession rates
  - Vary spatially (within beach compartment) and temporally (analysis period)
  - Estimated by analysis of a photogrammetry dataset spanning a sufficiently-long time period (shoreline movement → linear regression)
- Triangular distribution (for unknown distribution)

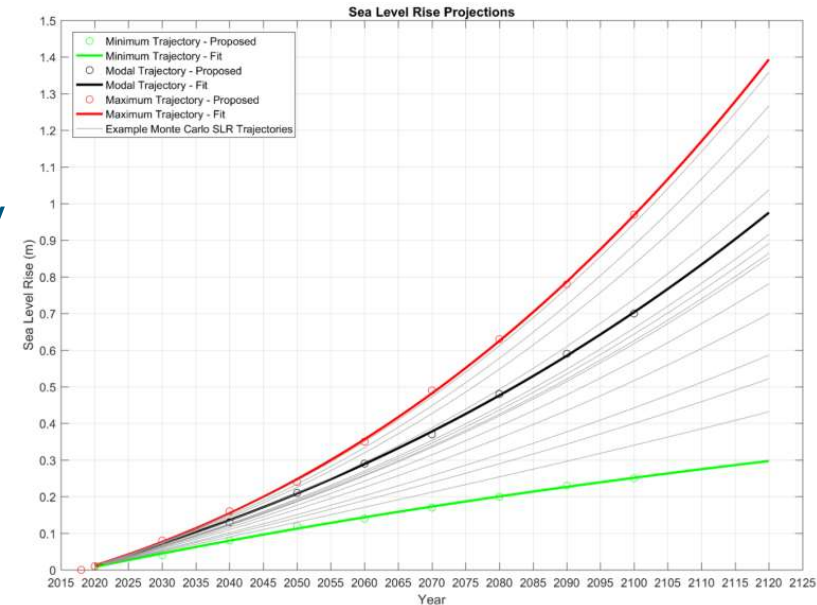
## Values and Distributions - SLR

- Shoreline response rates due to sea level rise
  - Shoreline recession due to re-adjustment of the beach profile
- Function of SLR and beach slope
- Defined by separate triangular probability distributions and minimum, maximum and peak/modal values

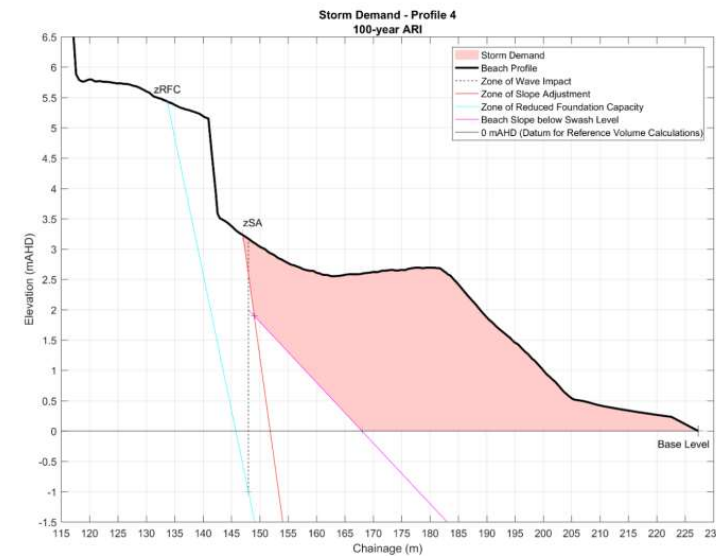
## Values and Distributions - SD

- Storm demand volumes
  - Volume of sand removed from a beach in a severe storm or a series of closely spaced storms
  - Estimated by modelling or analysis of historical beach profiles (if available)
- Typically defined for a 100-year ARI event and an appropriate curve fitted to enable the estimation of smaller return period events
- Normal distribution of annual exceedance probability or AEP → translated back to storm demand volume

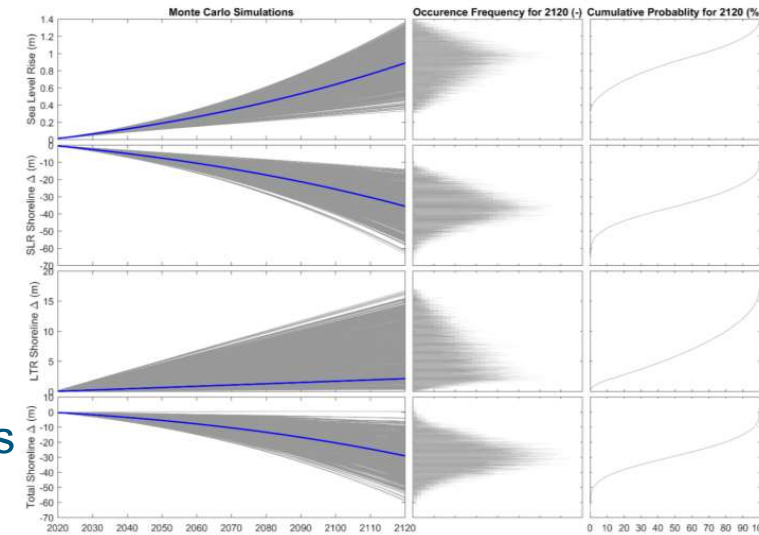
# Monte Carlo Analysis

- Monte Carlo modelling approach:
  - Sample each of these likely ranges many times (e.g., 100k or 1M, enough for output statistics to converge) to generate a distribution of potential total erosion setbacks

- Erosion hazard (setback) calculation:
  - Extract a particular selected output from this distribution (distance in meters)
  - Apply landward from an established 'baseline' shoreline position
  - Result: total shoreline movement along the beach (at each beach profile location)

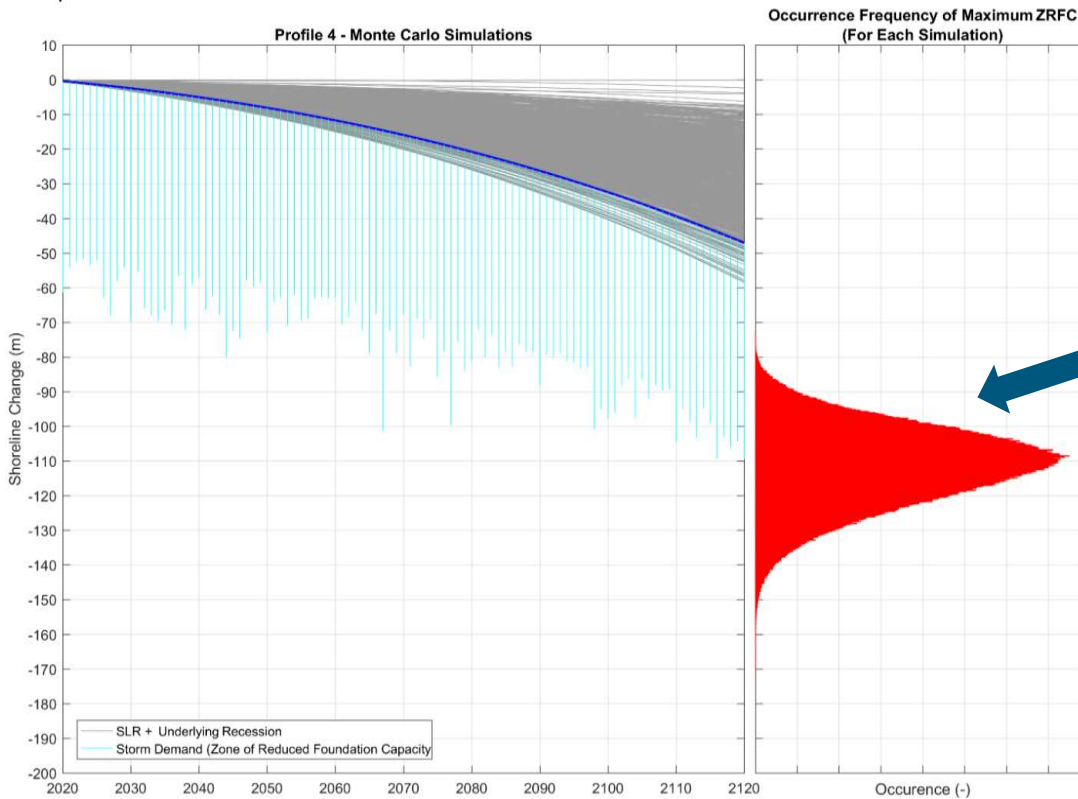
# Total shoreline movement

- Combined shoreline position due to LT, SLR and SD

- Distribution of 1M values of total shoreline change in a particular year
- Used to calculate probabilities of exceedance and produce hazard line on a map

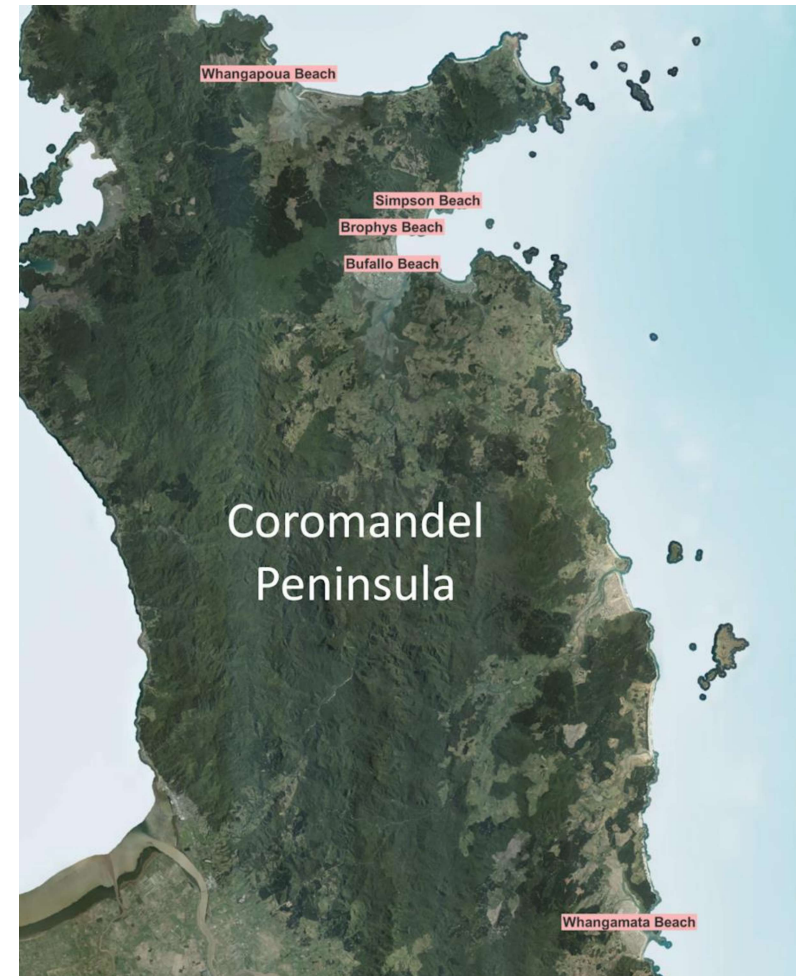
## Review locations

- Review of PCHA lines at locations that were affected by the two cyclones:
  - Whangamatā Beach
  - Simpson Beach
  - Brophys Beach
  - Buffalo Beach
  - Whangapoua Beach

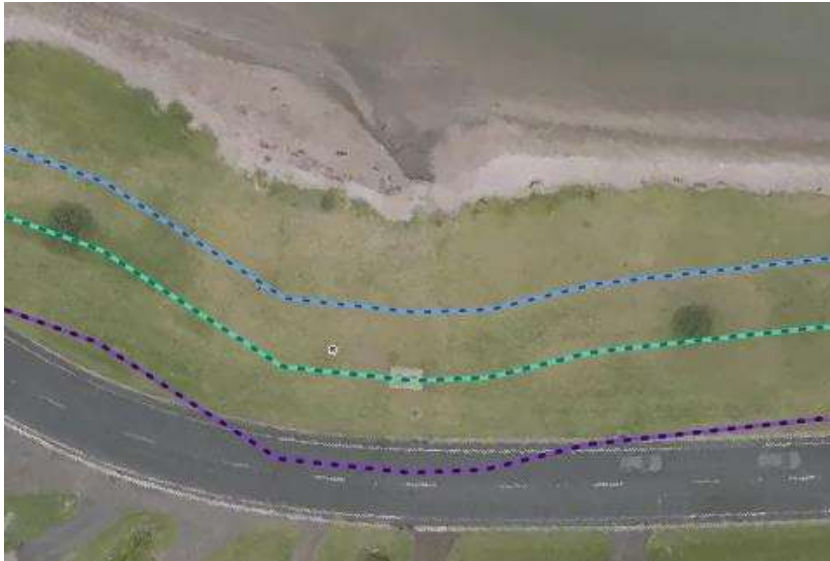
PCHA

# Brophys Beach

Existing 1% exceedance hazard lines for the years 2020, 2040, 2070 and 2120 were compared against the coastal erosion line captured on photographic data and drone images

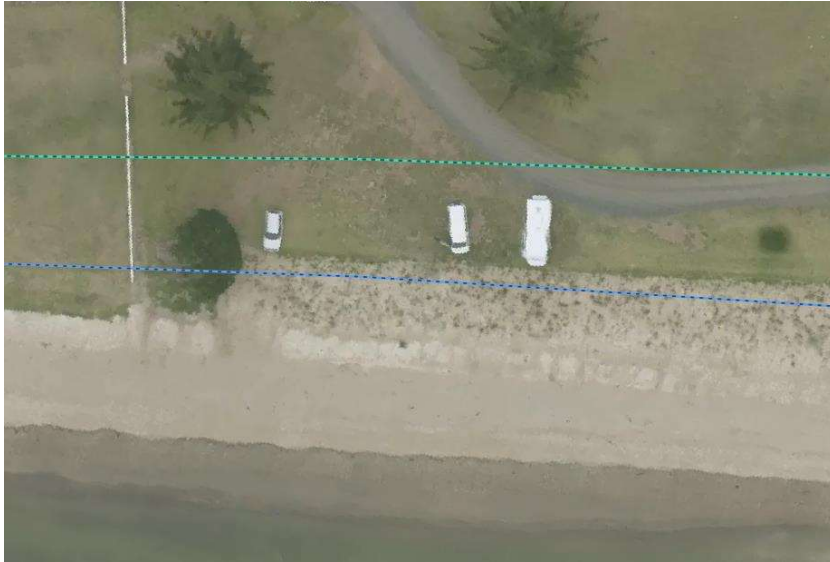
PCHA

# Buffalo Beach

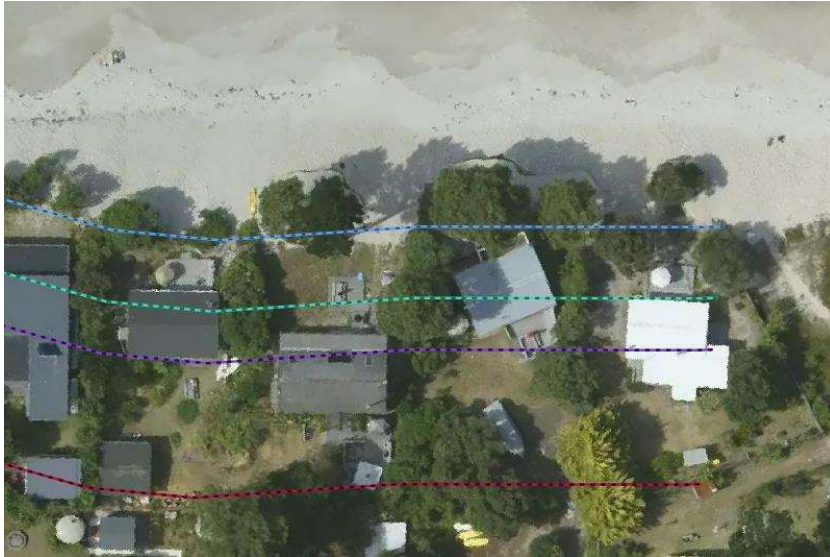
PCHA

# Whangapoua Beach
