Upgrade, Reinstate, or Retreat? A Comparison of Breakwater Asset Management Strategies

Chris Leaman – National Maritime Team Lead
Eloise Rossetto, Kyra Stem, Peter Cummings and Michael Moss

PIANC 2024, Sydney Australia
28 August 2024

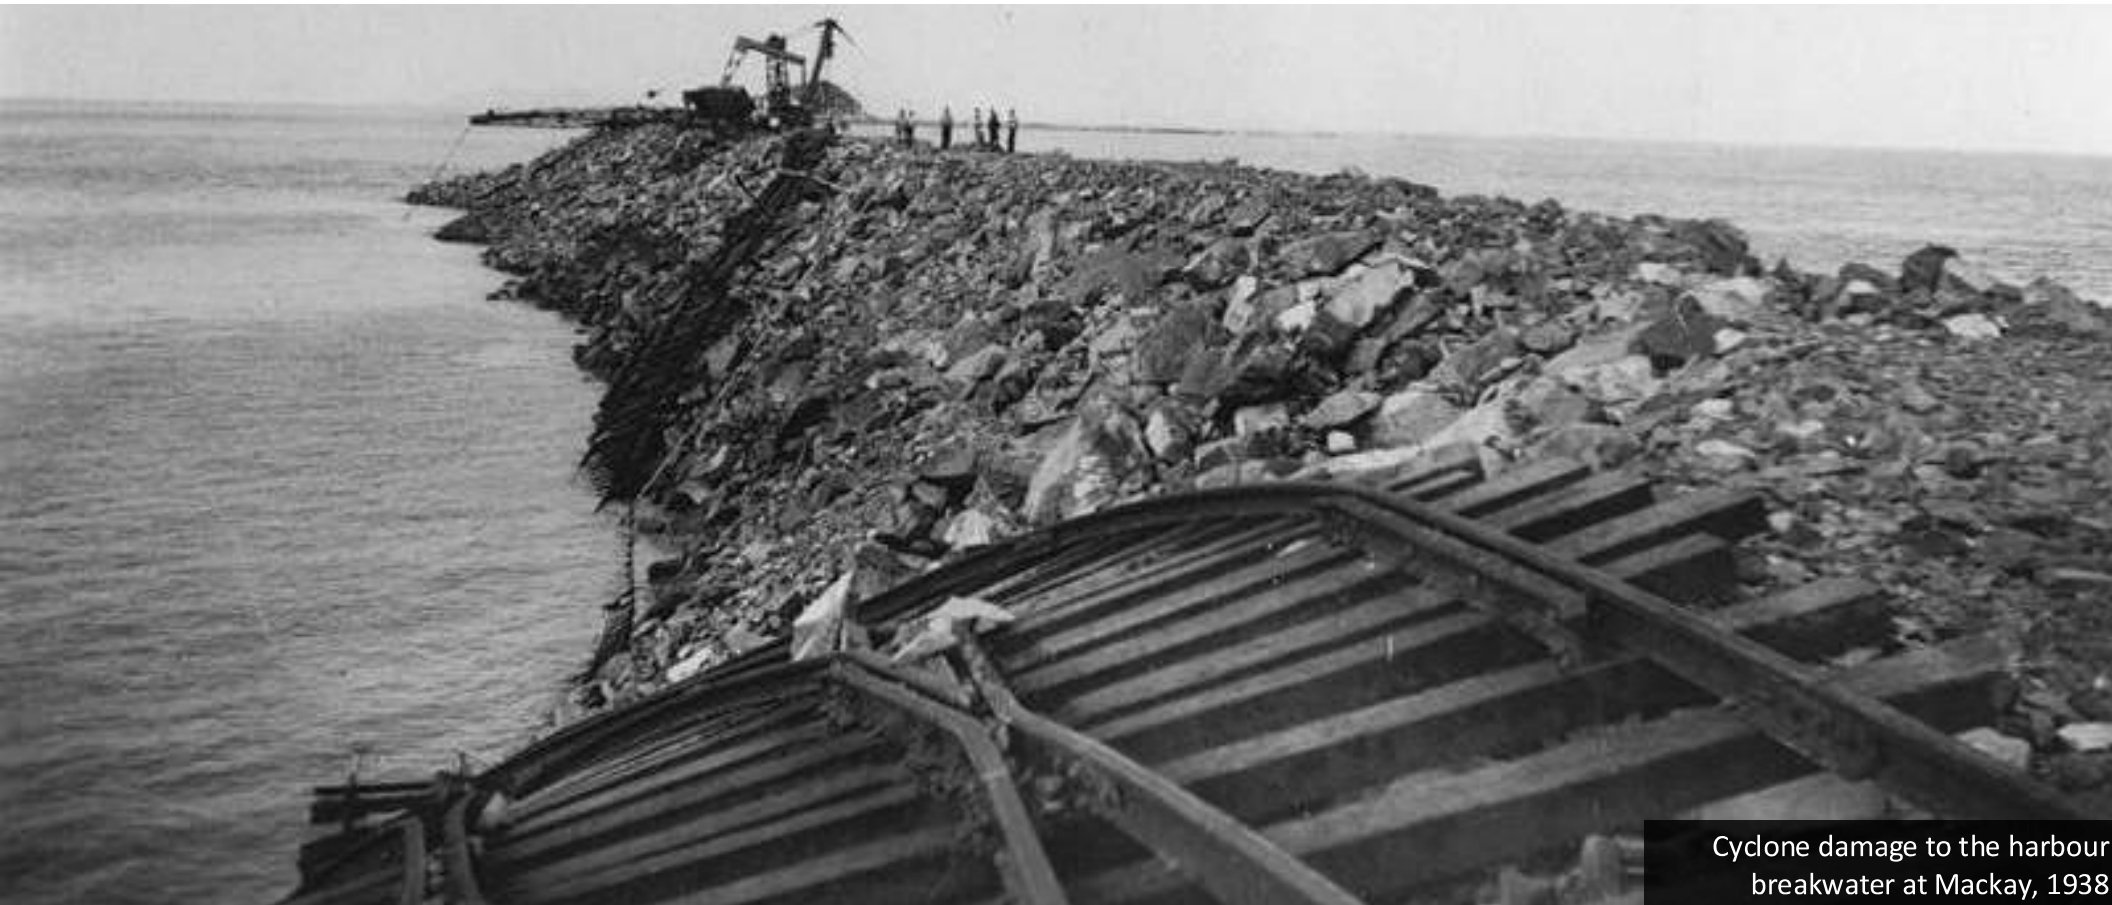
Port of Mackay (1938)

Cyclone damage to the harbour
breakwater at Mackay, 1938

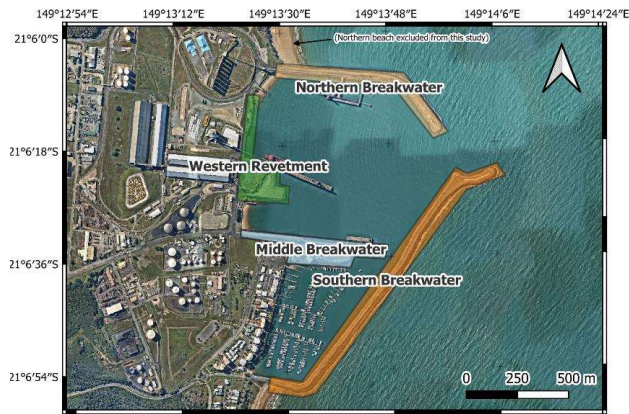
Port of Mackay – Breakwater parameters

Structure	Length	Crest	M50	Slope
Northern Breakwater	900 m	9.6 to 10 mLAT	0.44 to 7.4 t	1:2
Southern Breakwater	1700 m	10.0 to 11.6 mLAT	1 t to 23 t	1:2 to 1:3
Middle Breakwater	700 m	9.7 mLAT	1.5 t	1:1.5 to 1:2
Western Revetment	1000 m	10.4 mLAT	0.4 to 2.6t	1:1.5 to 1:2

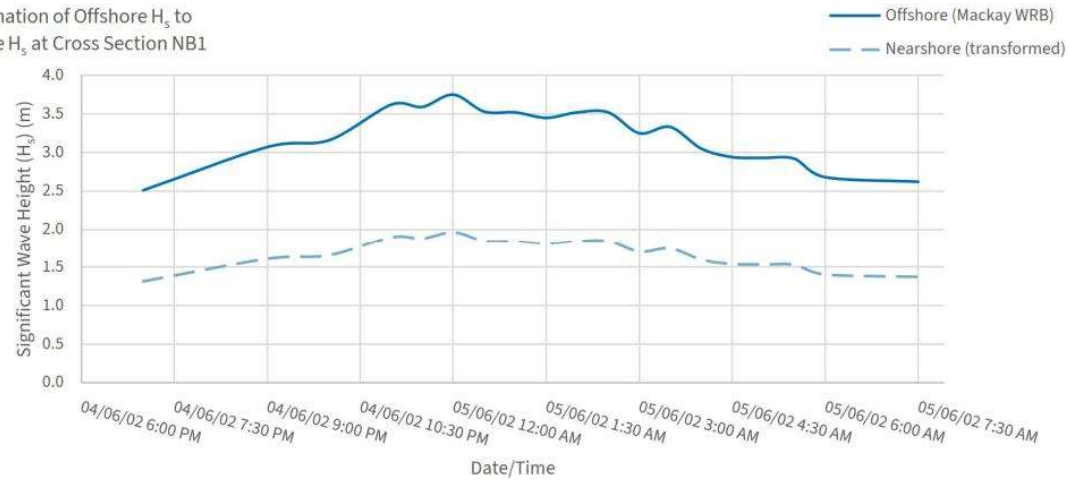
Transformation of Offshore H_s to Nearshore H_s at Cross Section NB1

Storm ID	ARI	Date	Name
1	5	04/06/2002	
2	5	19/01/2002	
3	50	20/03/2010	TC Ului
4	10	30/01/2014	TC Dylan
5	20	28/03/2017	TC Debbie

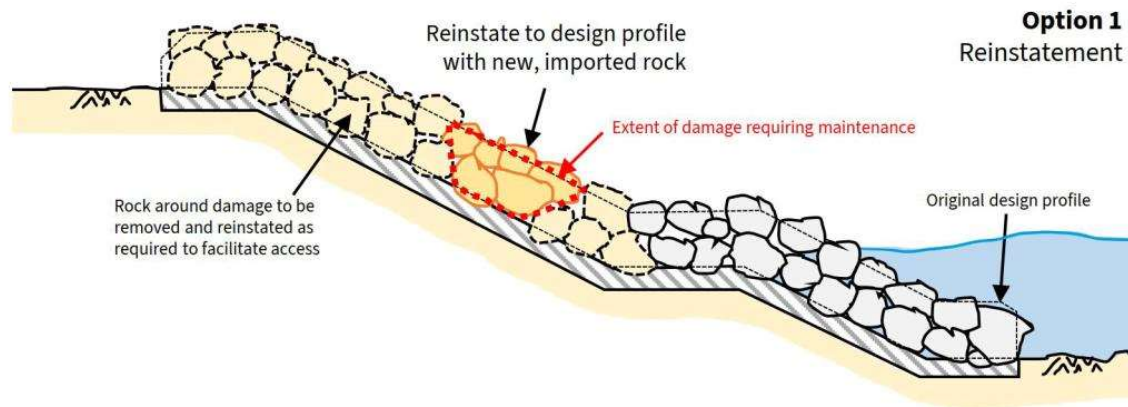
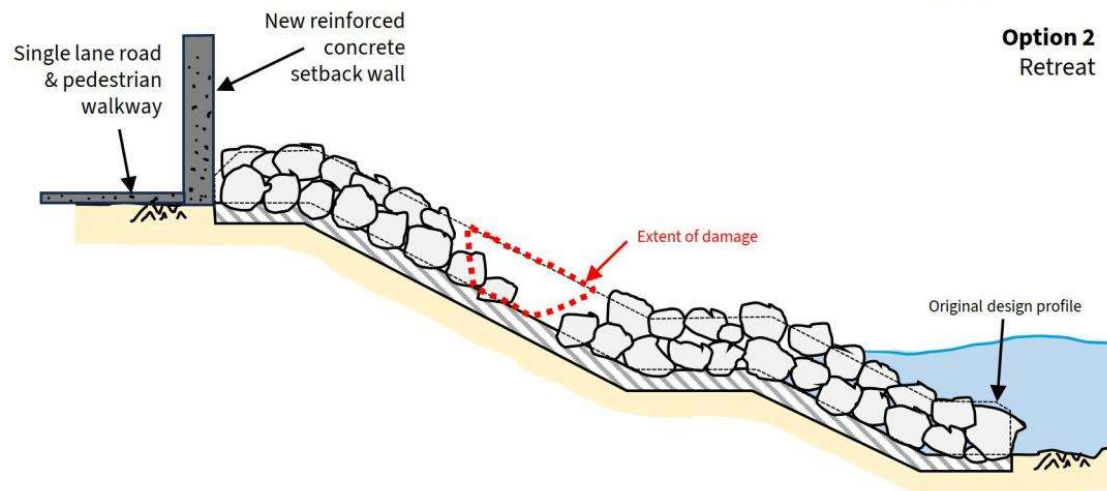
Maintenance Options – Reinstatement & Retreat

- **Option 1:** Reinstatement (base case)
- **Option 2:** Retreat
- **Option 3:** Monitor
- **Option 4:** Reprofile using existing rock
- **Option 5:** Partial progressive overlay upgrade
- **Option 6:** Full replacement of armour layer

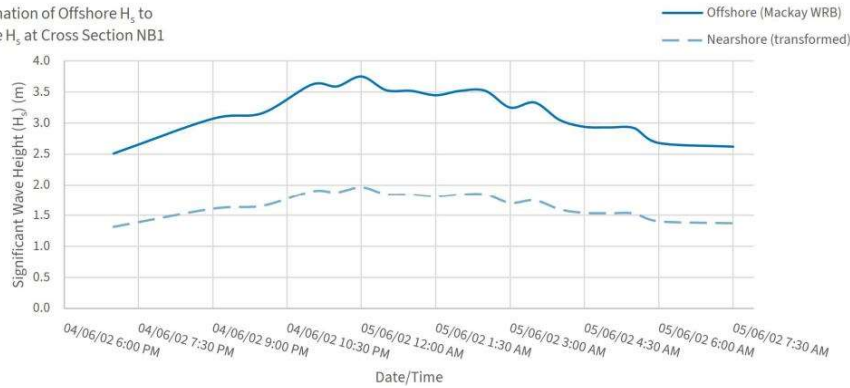
Transformation of Offshore H_s to Nearshore H_s at Cross Section NB1

Storm ID	ARI	Date	Name
1	5	04/06/2002	
2	5	19/01/2002	
3	50	20/03/2010	TC Ului
4	10	30/01/2014	TC Dylan
5	20	28/03/2017	TC Debbie

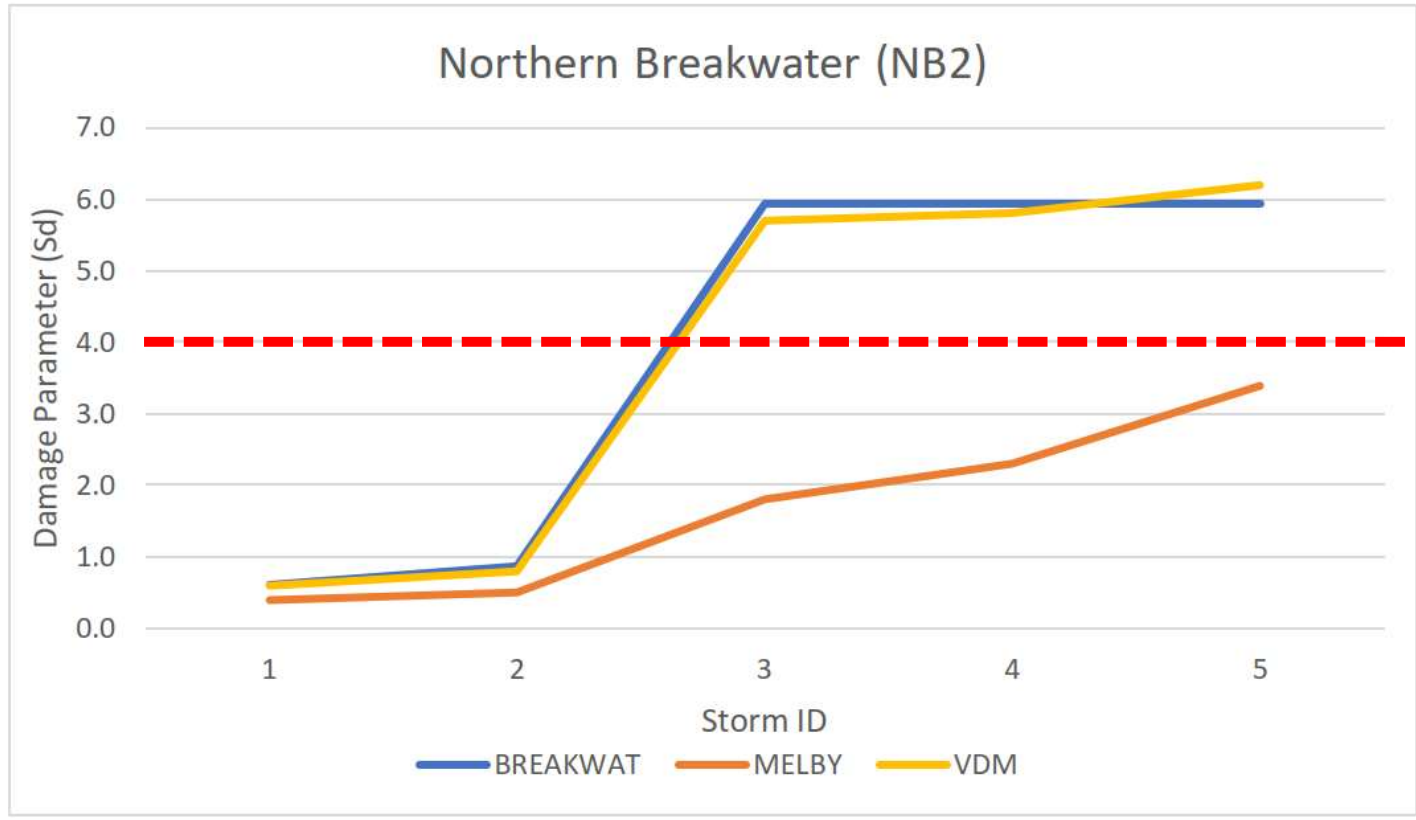
Results – Damage parameter

Sd > 4 triggers repairs

Structure	Section	Reinstate	Monitor	Partial upgrade	Full upgrade
Northern breakwater	1	2,300	Stable	-	44,000
	2	1,600	Stable	-	13,800
	3 (Roundhead)	1,500	-	-	0
Southern breakwater	1	49,200	Instable	8,300	53,950
	2	29,200	Instable	8,600	53,950
	3 (Roundhead)	0	-	-	0
Middle breakwater	1	0	-	0	0
Western revetment	2	2,400	-	1,500	30,300
