# Sustainability, Durability and Repair for Concrete Ports and Harbours: Insights from FIB Model Code 2020

Frank Papworth

# Sustainability, Durability, Construction & Repair

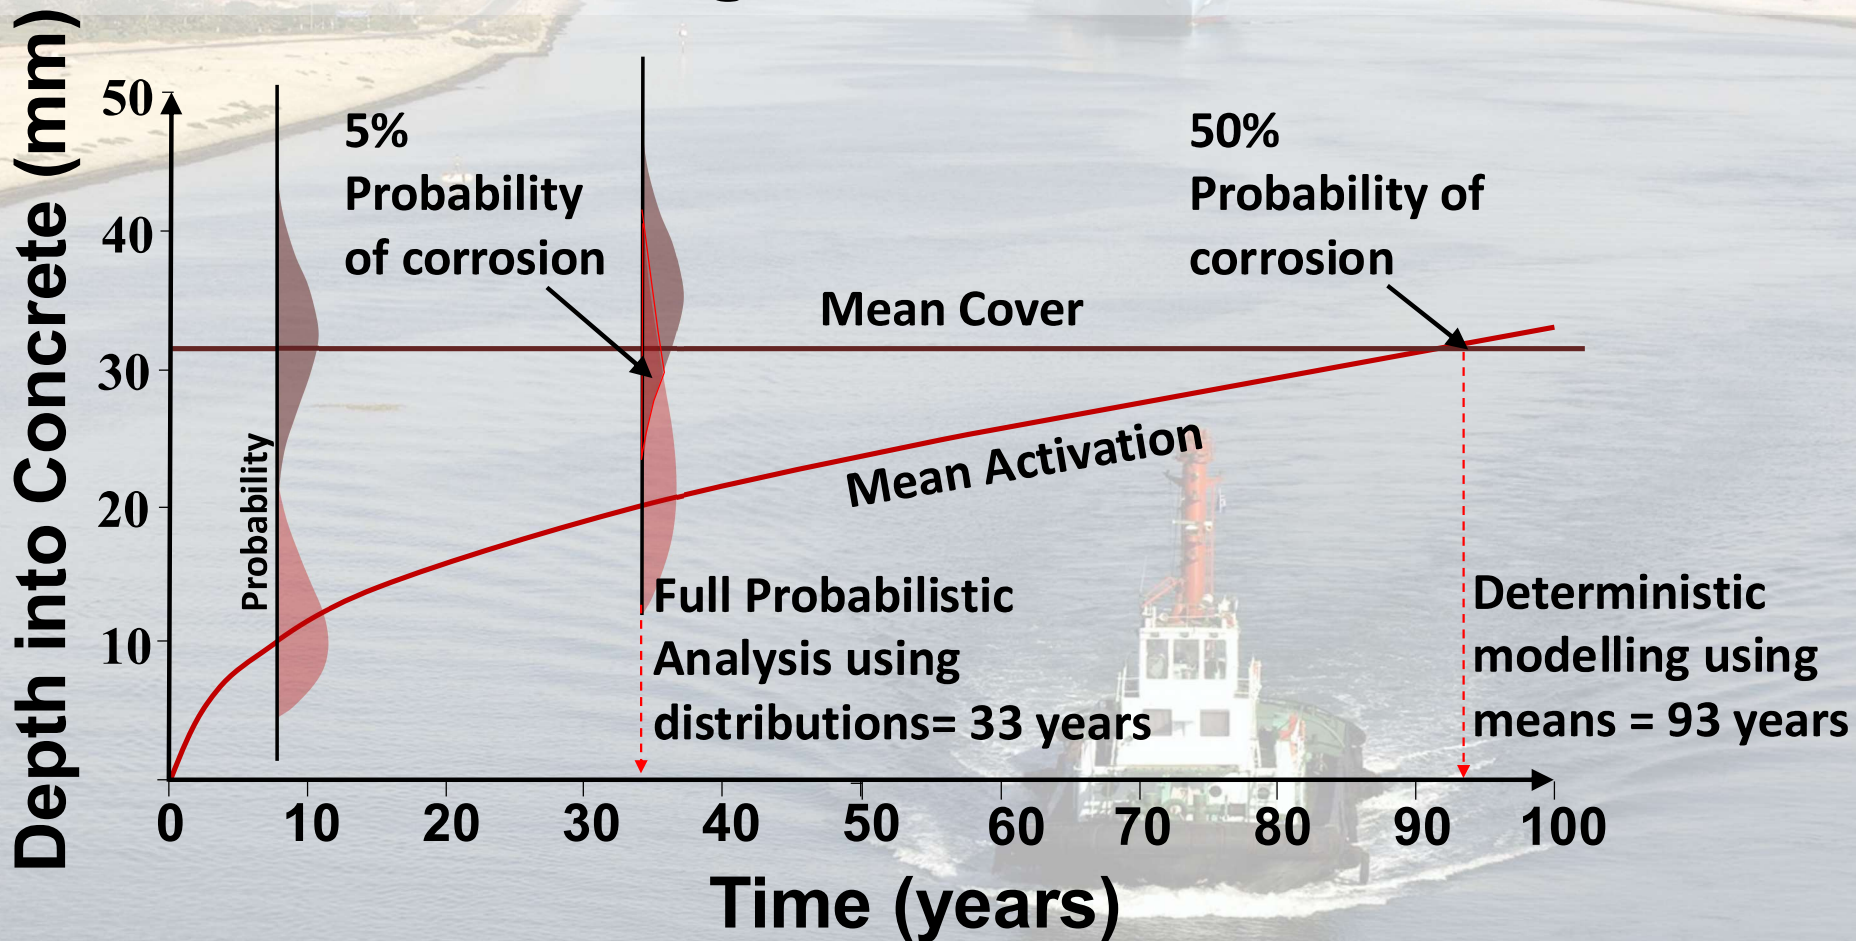
# Understanding Variables as Distributions

- Failure (e.g. corrosion) occurs due to many mechanisms
  - e.g. Mechanism = chloride ingress rate, variables = chloride diffusivity, surface chloride level
  - Variables have a distribution.
- Hence life modelling has to be based on probabilistic analysis (e.g. Monte Carlo).

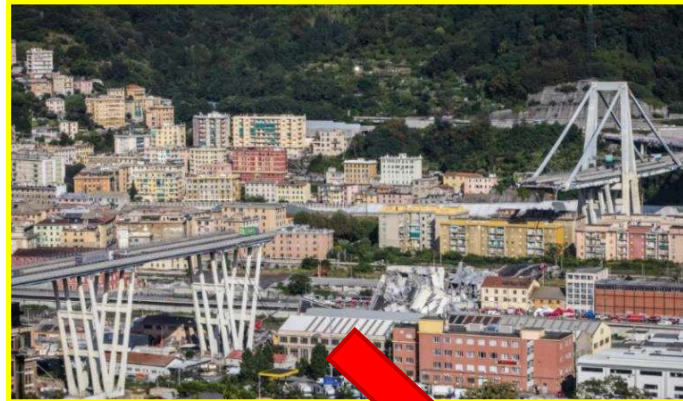
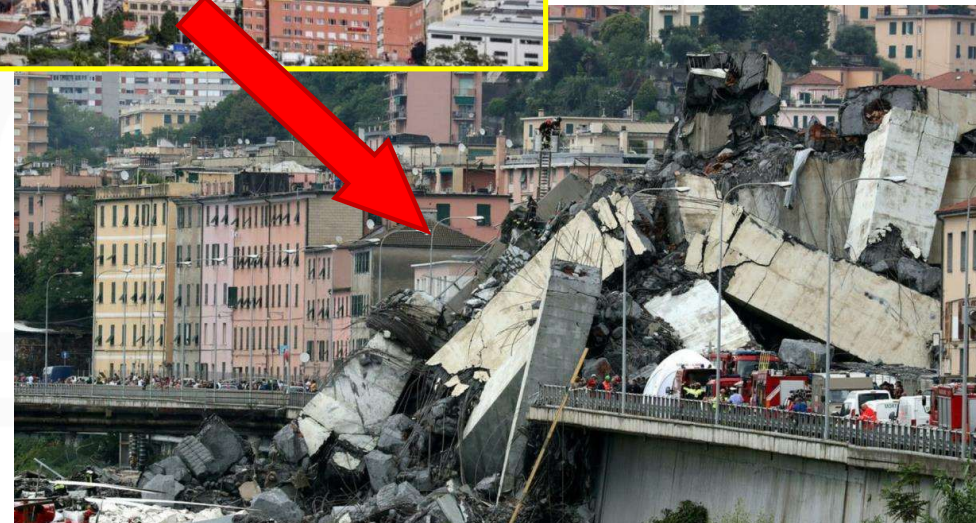
In 2018 the 1967 Morandi Bridge (Genoa) collapsed due to corrosion of a stay cable.

43 died. The replacement bridge has robots for cleaning and inspection.

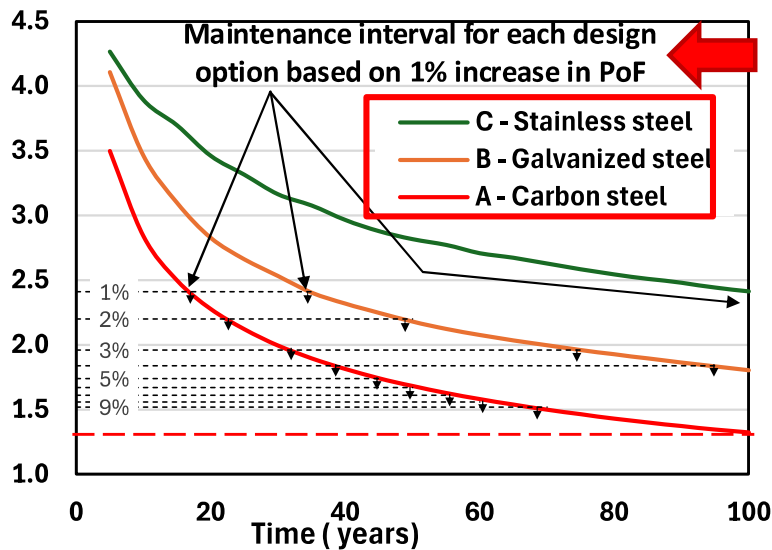
# LCCA – Major NSW Marine Structure

Case 1: Code requirement + B80			
St dev = 6 mm for cover			FA Mix
Drcm,0	5.0*10 <sup>-12</sup> m <sup>2</sup> /s, COV= 0.2		
Cover	75 mm	75 mm	75 mm
	β		
Time (years)	A - Carbon steel	B - Galvanized	C - Stainless steel
20	2.28	2.83	3.46
40	1.81	2.32	2.96
60	1.58	2.08	2.71
80	1.43	1.93	2.54
100	1.32	1.80	2.41

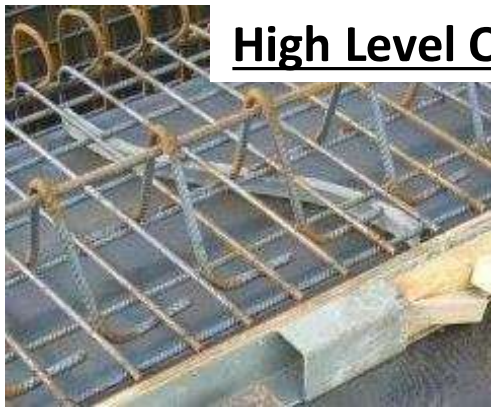
## Advanced Mix Design

SCC – avoids poor compaction

V.Low Sorptivity –  $0.036\text{mm/m}^{0.5}$

V.Low Chloride diffusivity  $1.37 \times 10^{-12} \text{ m}^3/\text{sec}$ .

Very high resistivity – 45.6 k Ohm.cm

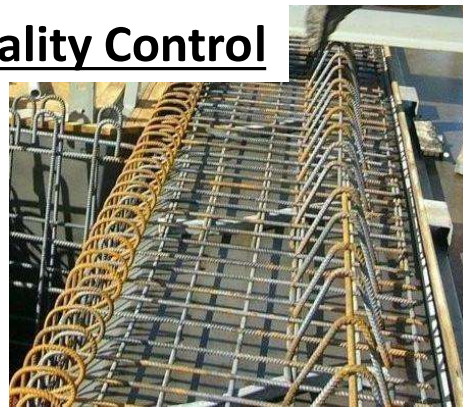
### High Level Quality Control

High-performance bar spacers  
located to BS 7973 ensure  
2mm tolerance

Well-tied reinforcement  
maintains 2mm  
tolerance

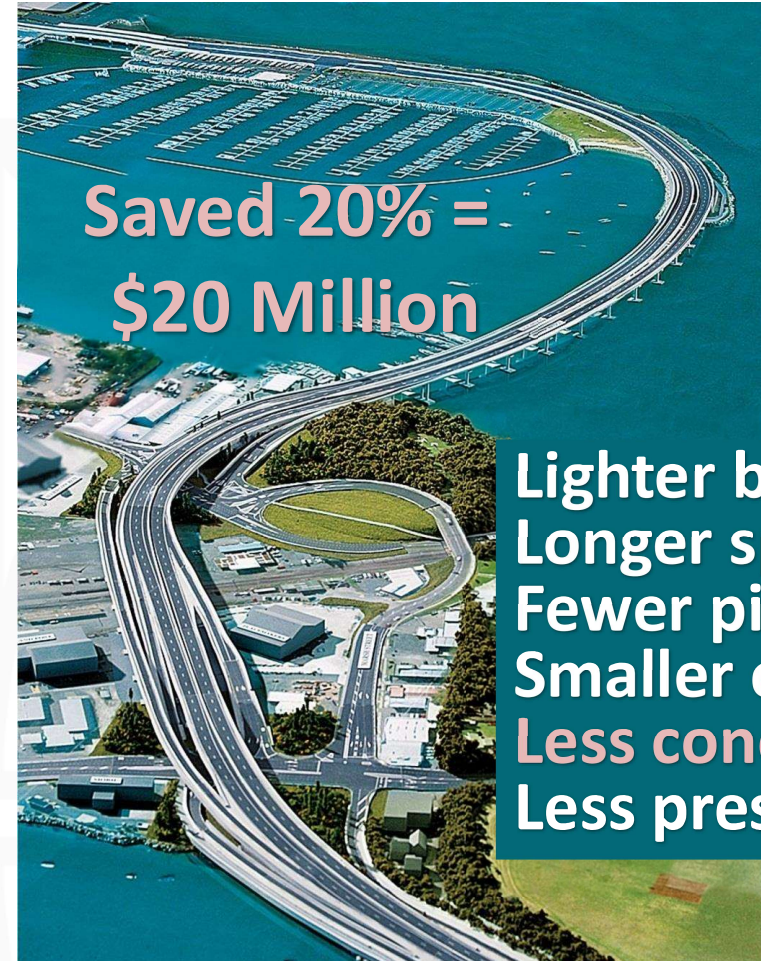
# Tauranga Harbour Link

Saved 20% =  
\$20 Million

Lighter beams  
Longer spans  
Fewer piers  
Smaller cranes  
Less concrete  
Less prestress

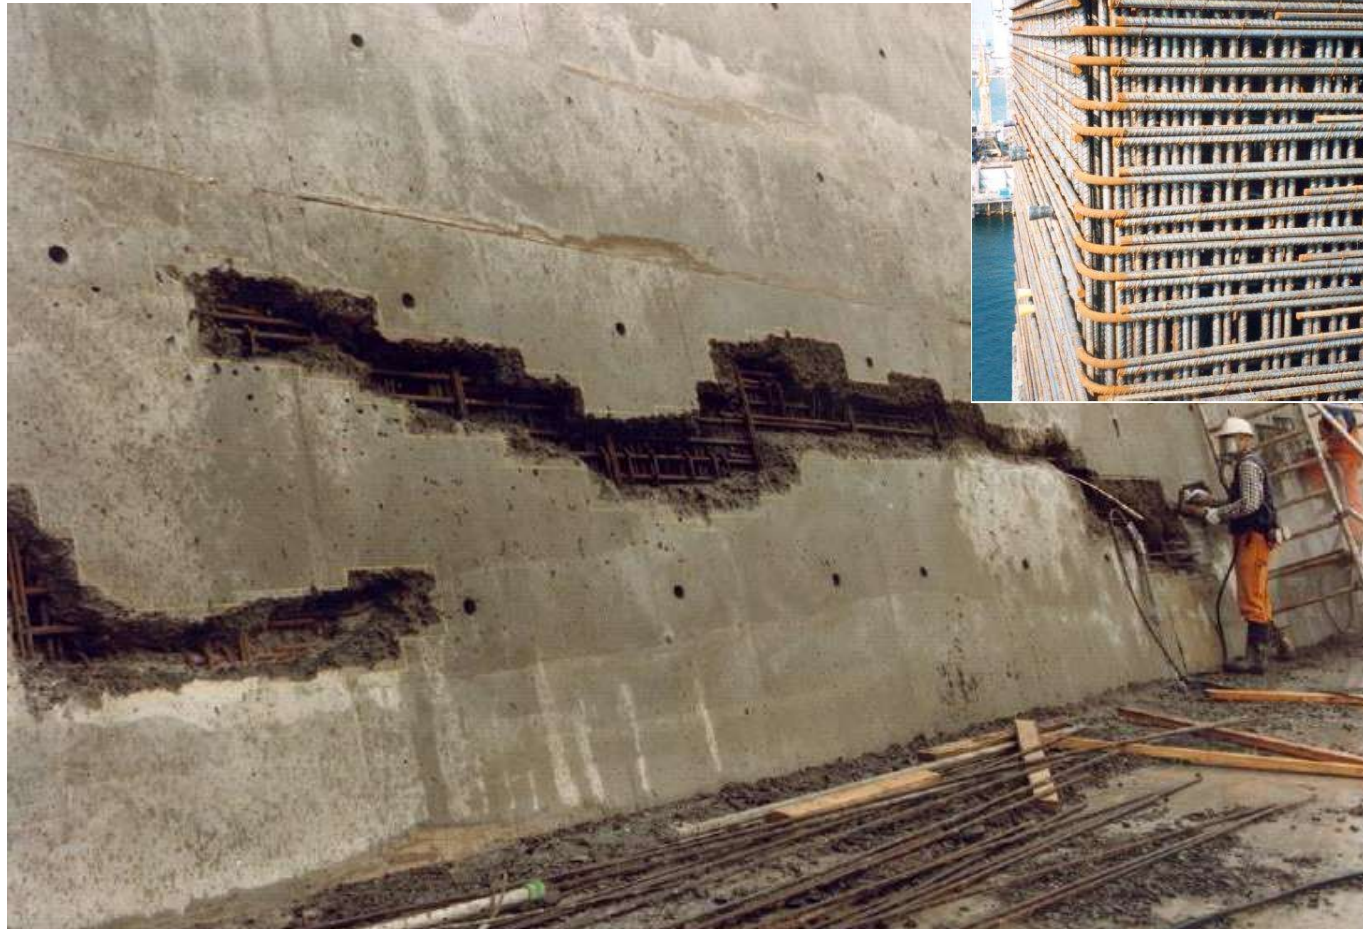
# Construction as a Special Process

- **Construct to avoid defects**
- **Issues**
  - Cause
  - Hidden Defects
  - Program
  - Construction Cost
  - Structural
  - Repair Durability

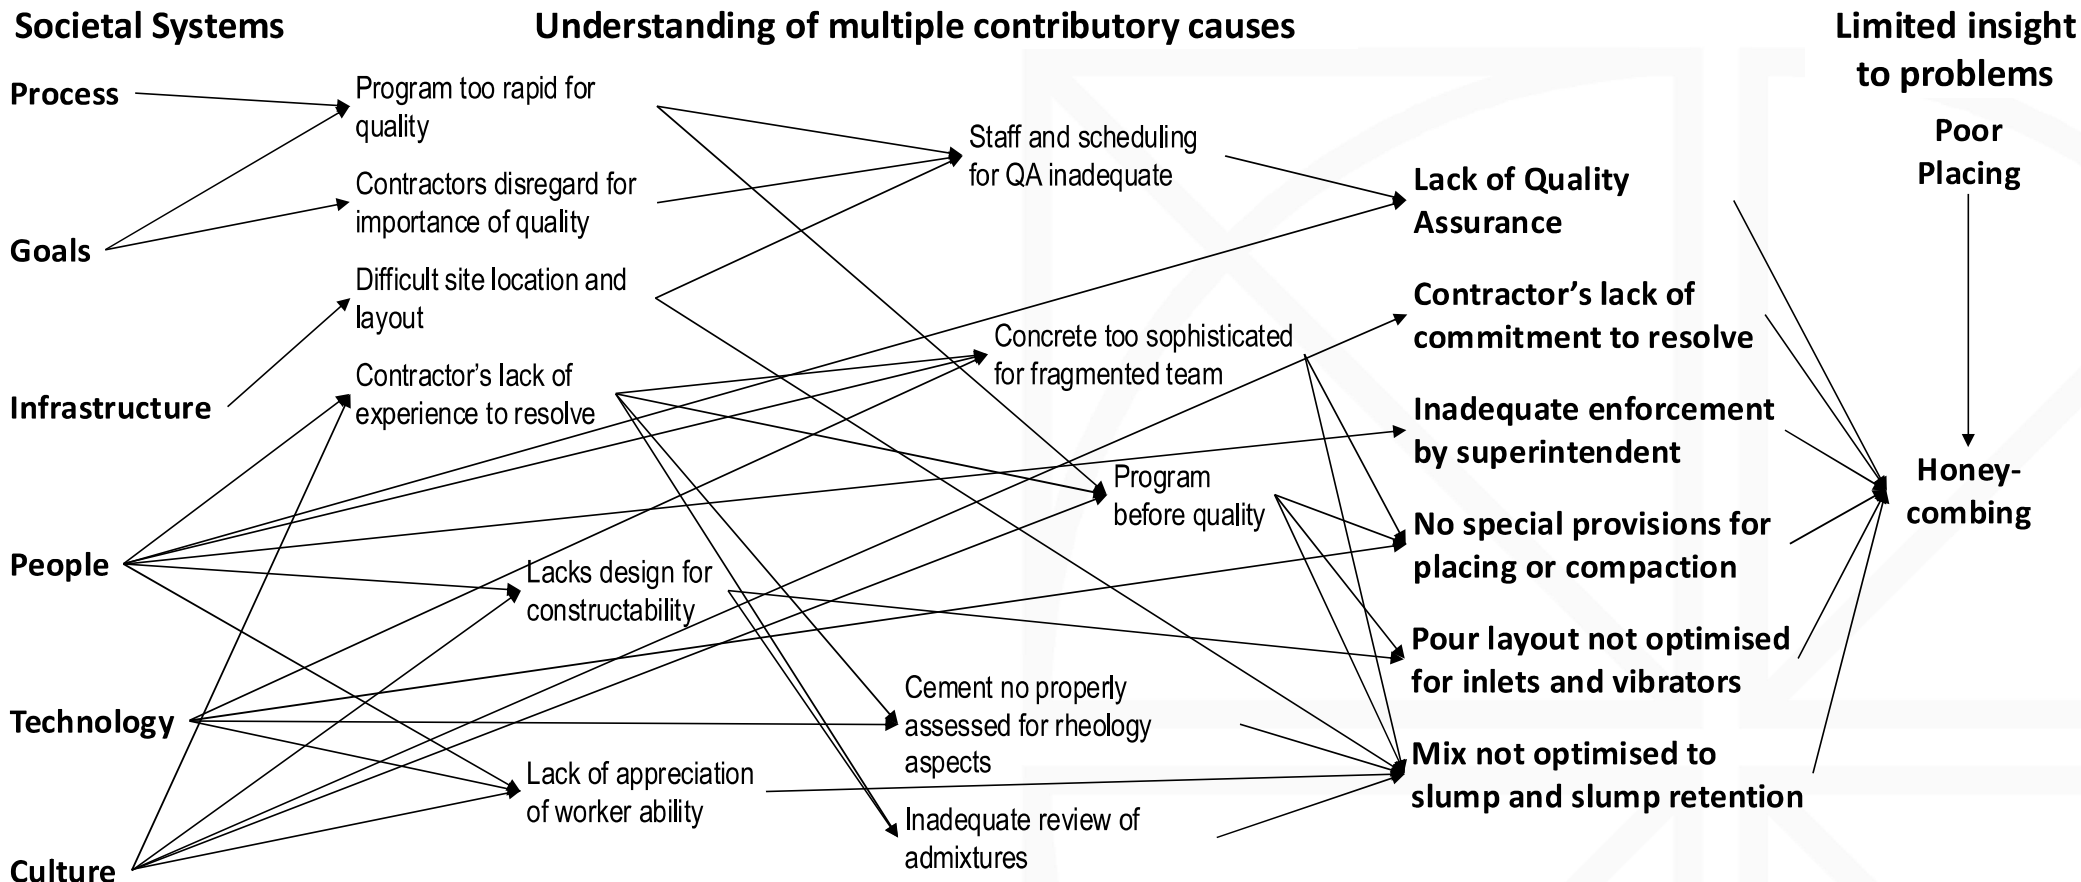
# Concrete Compaction Failure Analysis

## It is not Just Poor Placing!
