Gellibrand Pier

- Williamstown, Melbourne
- Built in 1850s for wool & grain trades

Upgrade of Spring Dolphins

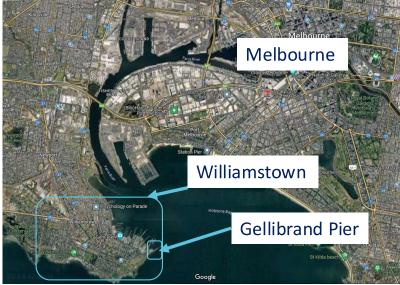
Gellibrand Pier

- Major upgrade in Mid-1960s
- Island Berth for bulk liquid

• MLA, 2 Berthing Dolphins, 6 Mooring Dolphins and TWO Spring Dolphins.

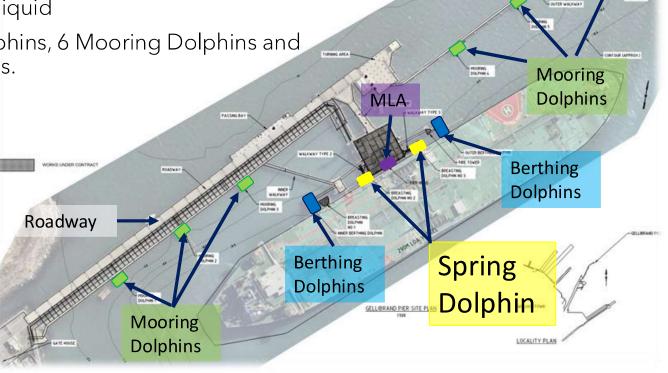
Existing Dolphins (BD2 & BD3)

- Built in 1960s
- 7 H piles (1960) + 2 x 900CHS Piles (2009)
- Used as breasting dolphins + spring mooring dolphin
- Piles with high corrosion in the tidal and splash zone (up to 10.5 mm corrosion loss)
- Concrete cap in very poor condition with exposed reinforcement

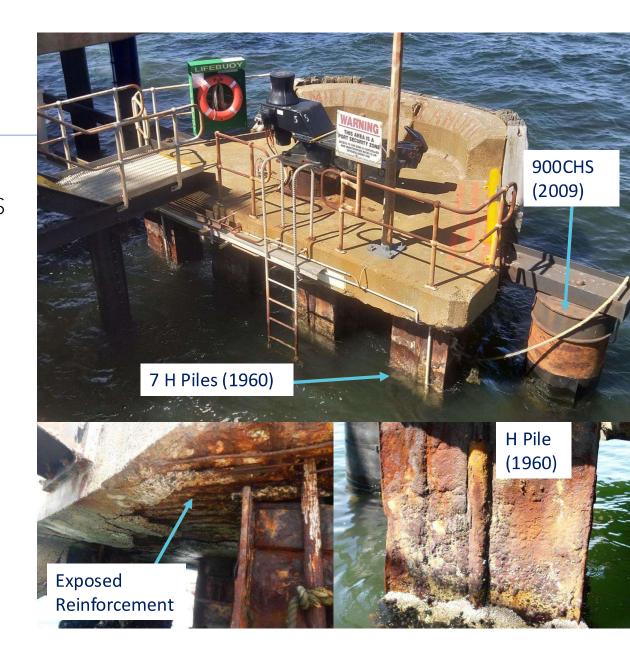
Main Goal: Enhance the capacity with minimum distruption to operation

- Design for a 176-tonne safe working load to build resilient infrastructure in line with United Nations Goal 9.
- The dolphin will not experience structural failure before reaching the ship's design minimum breaking load

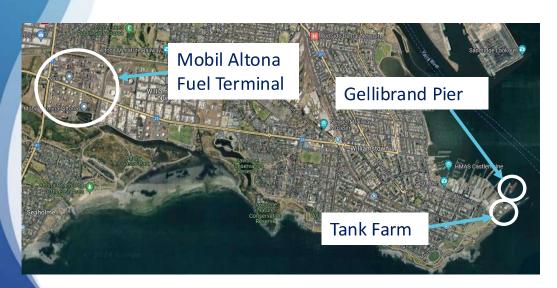
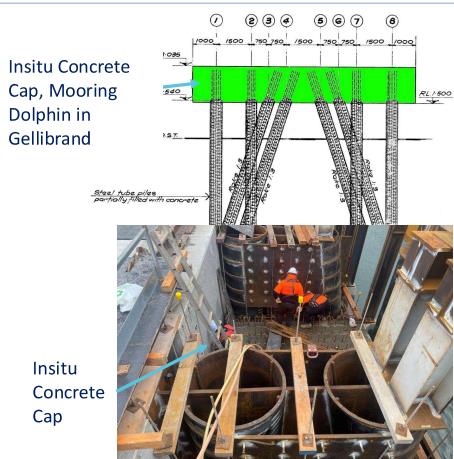
Site Specific Constraint

- Max planned shut down time = 2 weeks
- Use of precast concrete cap rather than a conventional in-situ concrete cap.

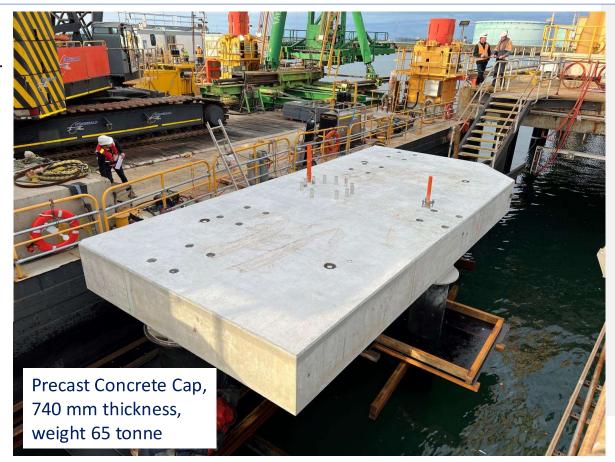
Precast Concrete Cap

- Limit weight to 70 tonnes.
- Adequate footprint for new piles
- Thin Cap (740 mm)
- Pin-top Pile Connection

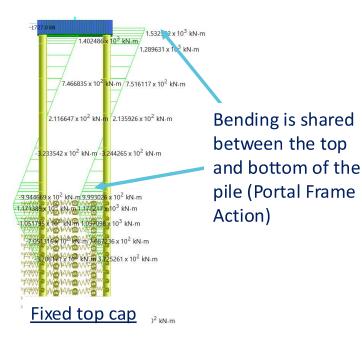
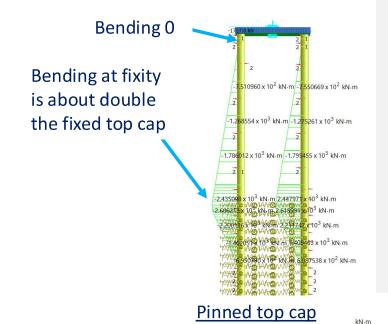
Pinned versus Fixed Top

- Fixed top requires a deep concrete cap, but piles are more efficient.
- Pinned top has a relatively thin concrete cap, but the bending moment at the fixity depth may double the amount of fixed top.

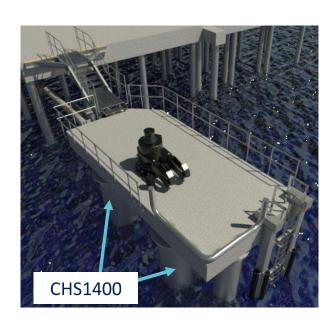
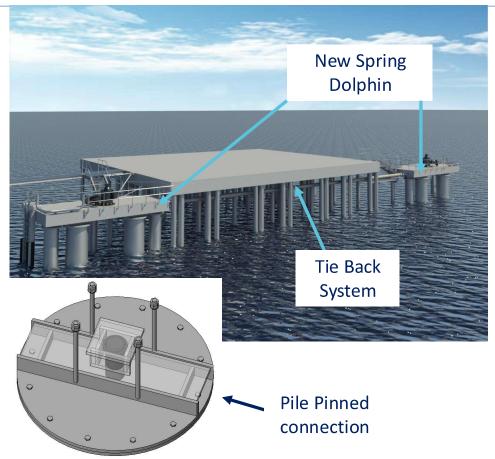
Design Development

- Connect dolphins using a tieback system.
- Drive the minimum number of new piles to reduce the time on site.

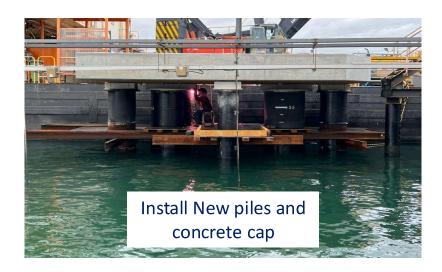
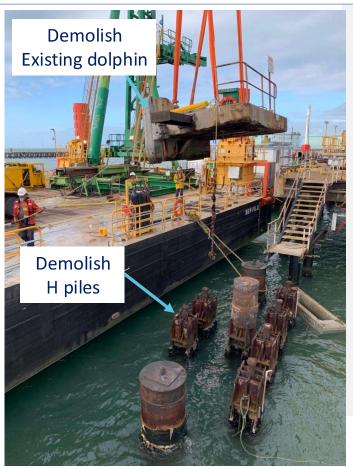
Construction Work

- ON-SITE work: Start March 2022, Finish June 2022 (four months).
- Demolition of existing dolphins and existing H piles.
- Install all new piles, concrete cap, QRH and modify existing 900 piles in less than ten days.
