Addressing Mooring Forces and Snapback Hazards

SAM MAZAHERI
PIANC APAC 2022 – MELBOURNE, 4-7 SEPTEMBER

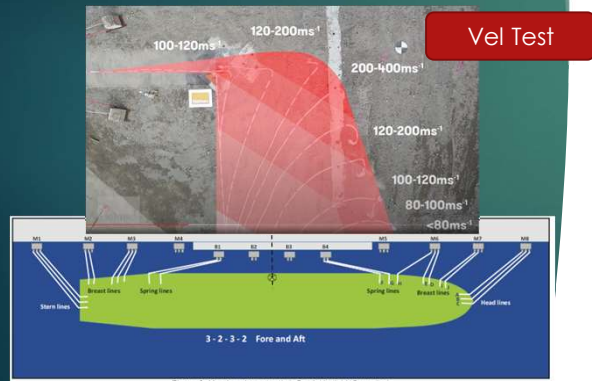
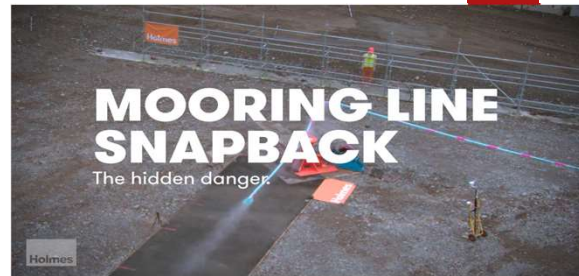
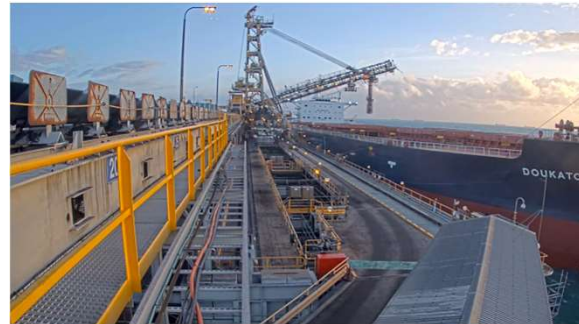
Snap-back

- ▶ Rupture in a mooring line
- ▶ Parted line snap-back like a rubber
- ▶ Significant Safety Risk to personnel on wharf and ship decks

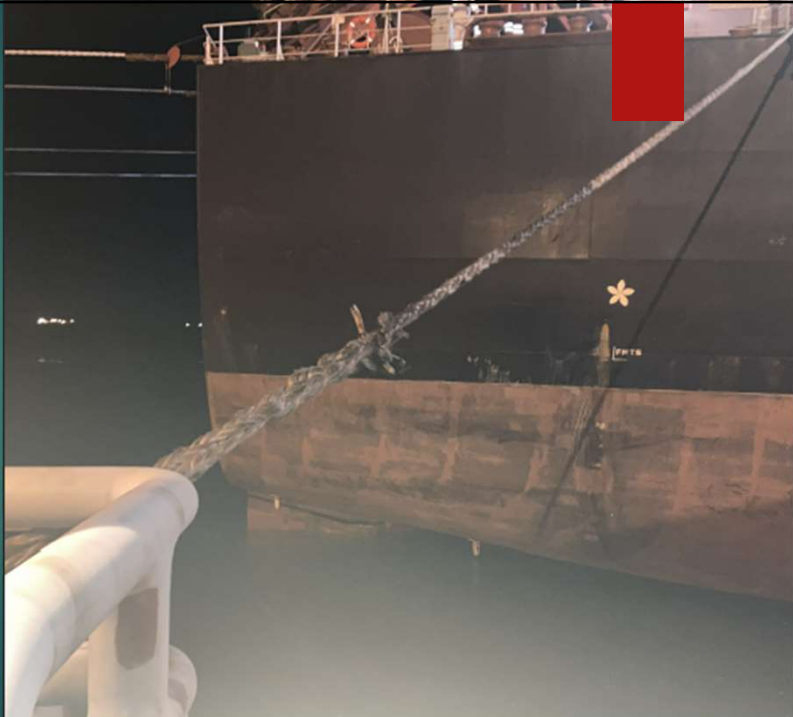
Incident recorded on 12 June 2022

- ▶ VLC Bulk Carrier (292m LOA)
- ▶ Mooring configuration 4+2+2
- ▶ Breast line was parted shortly after the high water
- ▶ A slight spike on the Berth Alert System was recorded although the system remained in the Green status

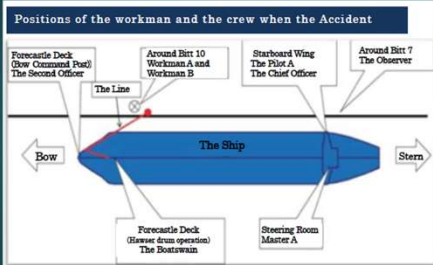
Positions of the workman and the crew when the Accident

weather at the time of the accident
 average wind speed: 3.6 ~ 3.7m/s
 max. instantaneous wind speed: 9.8m/s
 wind direction: NE

the break of the mooring
 A "spring line" is a mooring line taken backward from the bow, or taken forward from the stern.

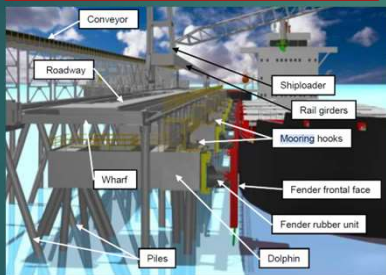
Linear Wharf Structure supported by piles

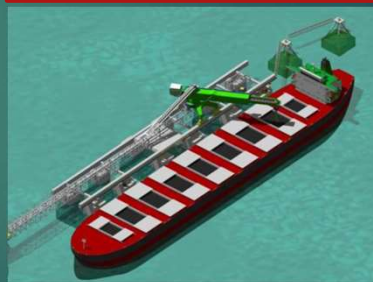
Linear Wharf Structure supported by caissons

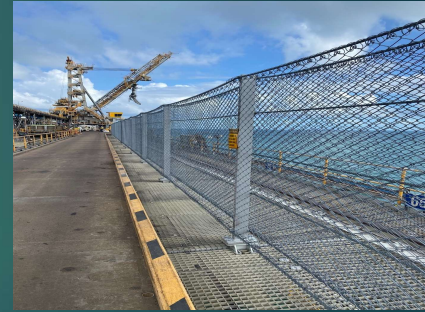
Fencing Sys

- ▶ Basis for Design
 - ▶ Rope tip impact velocity
 - ▶ Impact energy imparted on barrier

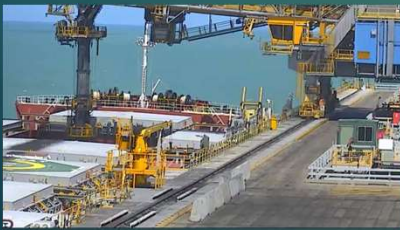
Concrete
