Garden Island Contaminated Dredging & Disposal Case Study

Summary

PIANC APAC 2022 – 2nd PIANC Asia Pacific Conference – Melbourne, 4-7 September 2022 Garden Island Contaminated Dredging Case Study Justin Sayer

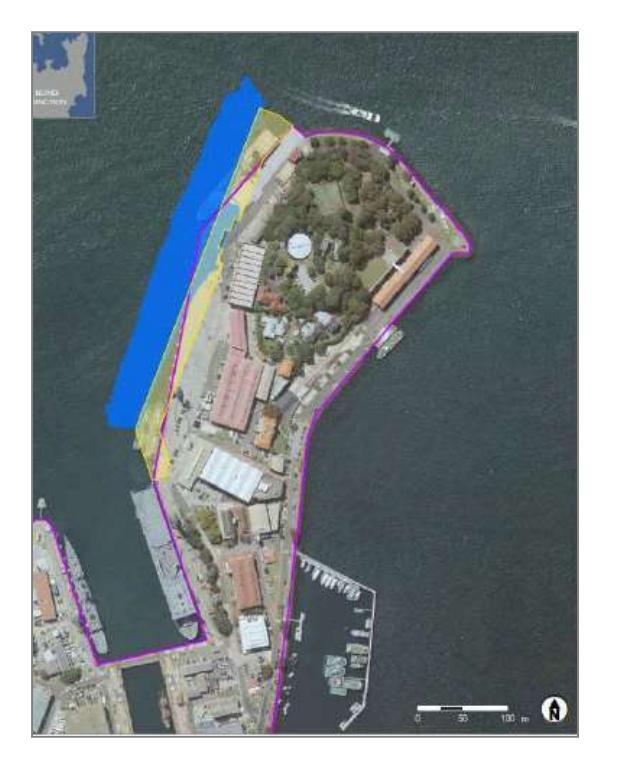
Figure 1 Dredge Pocket (blue shading) for the Garden Island Dredging Works (Source: [1]).

- Maintenance Dredging:
 - 18,500m³ of contaminated
 - materials (made ground/marine fill)
- Capital Dredging:
 - 8,000m³ of Clay materials
 - 1,000m³ of Rock materials

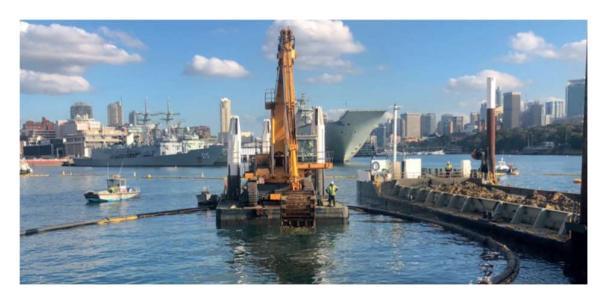
Figure 2 Birdon's Backhoe Dredge loading contaminated dredging materials into Birdon's split hopper barge at Garden Island (Source: [2]).

Birdon utilised its spud mounted backhoe dredge "BHD Sydney", with Liebherr 984 - 100 tonne excavator and bucket (with interchangeable ripper attachment for rock), and two spud mounted split hopper barges, Pelican (1000m3 capacity) and 139 (500m3 capacity), to dredge and remove the following materials:

- The RSW was loaded into Birdon's split hopper barges and transferred to a designated waste transfer facility.
- Due to the soft and saturated nature, the material was unsuitable for road transport in its original state.
- Birdon developed a proprietary polymer additive that was mixed into the material using two wharf-based 30 tonne long reach excavators, which rendered the material "spadeable".
- The material was then loaded into trucks for transport to the designated waste disposal facility.
